# Access Compliance Report

## Public Rights-of-Way

### (Curb Ramps)

| Intersection ID: 2516 | Main Street: ROCKY_FORD_CLUB_RD | Cross Street: EASTFIELD_RD | Location: S |

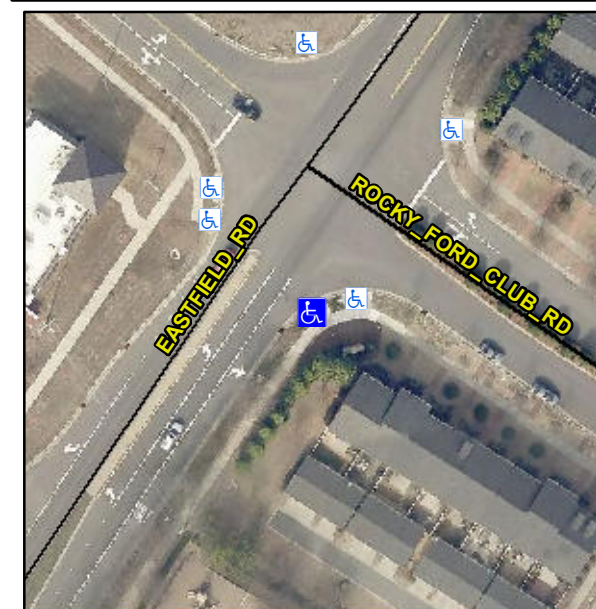
| ADA ID: A003F6959FFA | Ramp Type: Perp | Initial Pass/Fail: Pass | Overall Compliance: No |
| Severity Score: 0.25 | | | |

**R304.5.3**

| Compliance | Description | Data | Compliance | Description | Data |
|---|---|---|---|---|---|
| Yes | Ramp Width (in) | 48.0 | No | Ramp XSlope (%) | 4.9 |
| No | Landing X Slope (%) | 3.8 | Yes | DWS Full Width? | Yes |
| Yes | Gutter Lip Ht (in) | 0.0 | No | Gutter X Slope (%) | 4.5 |

**Remove & Replace Entire Ramp.  
Remove & Replace Gutter.**

Total Cost: \$ 2600.00
