# Access Compliance Report

## Public Rights-of-Way (Curb Ramps)

Intersection ID: N/A	Main Street: MAMMOTH_OAKS_DR	Cross Street: N/A	Location: N
ADA ID: A0072A0ACF5D	Ramp Type: Perp	Initial Pass/Fail: Fail	Overall Compliance: No
			Severity Score: 46.25

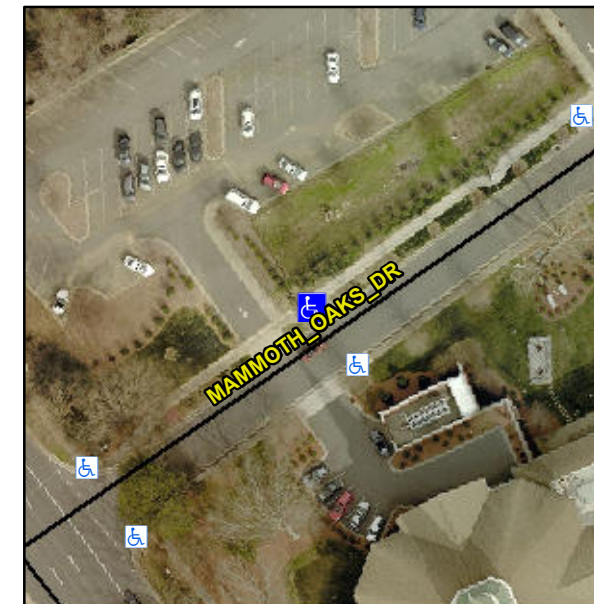
**Not Found, R304.5.1, R304.2.2,  
R304.5.3**

Compliance	Description	Data	Compliance	Description	Data
N/A	Ramp Length (in)	95.0	No	Ramp Slope (%)	8.8
No	Ramp Width (in)	47.5	No	Ramp XSlope (%)	11.2
N/A	Flare Type LT	N/A	N/A	Flare Type RT	N/A
N/A	Flare Slope LT (%)	N/A	N/A	Flare Slope RT (%)	N/A
N/A	Flare Traversable LT?	N/A	N/A	Flare Traversable RT?	N/A
N/A	Landing Length (in)	N/A	N/A	DWS Provided?	N/A
N/A	Landing Width (in)	N/A	N/A	DWS Contrast?	N/A
N/A	Landing Slope (%)	N/A	N/A	DWS Length (in)	N/A
N/A	Landing X Slope (%)	N/A	N/A	DWS Full Width?	N/A
N/A	Landing Curb? (Y/N)	N/A	N/A	DWS Offset (in)	N/A
N/A	Shared Landing?	N/A			
N/A	Gutter Ponding?	N/A	N/A	Gutter Slope (%)	N/A
N/A	Gutter Lip Ht (in)	N/A	N/A	Gutter X Slope (%)	N/A
N/A	Painted X Walk1?	No	N/A	Painted X Walk2?	N/A
	X Walk 1 Direction	To SE		X Walk 2 Direction	N/A
N/A	X Walk 1 Width (in)	N/A	N/A	X Walk 2 Width (in)	N/A
	X Walk 1 Slope (%)	1.0		X Walk 2 Slope (%)	N/A
	X Walk 1 X Slope (%)	9.8		X Walk 2 X Slope (%)	N/A

N/A	Ramp inside XWalk1?	N/A	N/A	Ramp inside XWalk2?	N/A
	Road Slope (%)	N/A	N/A	Clear Space?	N/A
	Road X Slope (%)	N/A	N/A	Clear Space to XWalk (in)	N/A
N/A	Any Obstructions?	N/A	N/A	Storm Grate/Utility Hazard?	N/A
	Obstruction Type			Storm Grate/Utility Type	
		N/A			N/A
			Yes	Surface Condition? (G/P)	Good

**Remove & Replace Entire Ramp.**

Total Cost: \$ 1850.00
