Access Compliance Report

Public Rights-of-Way

(Curb Ramps)

Intersection ID: 28499	Main Street: BIRD_WATCH_LN	Cross Street: NORTHWOODS_FOREST_DR	Location: S
ADA ID: A010E6DE9ACB	Ramp Type: BlendTrans2	Initial Pass/Fail: Fail	Overall Compliance: No
Severity Score: 17.5			
Codes/Mitigation Info/Possible Solution		Field Measurements/Component Compliance

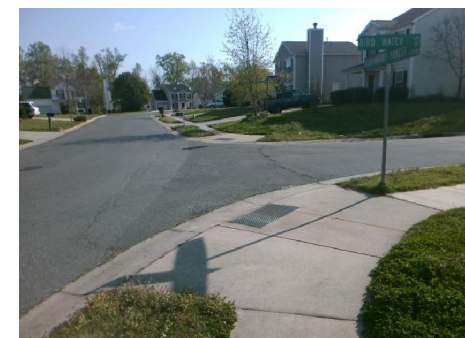
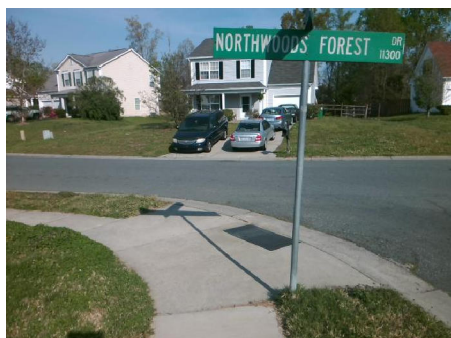
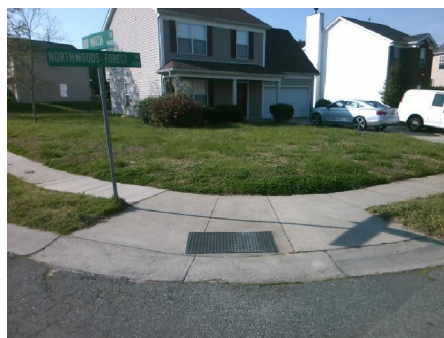
Compliance	Description	Data	Compliance	Description	Data
N/A	Ramp Length (in)	96.0	Yes	BlendTrans Slope (%)	4.2
No	Ramp Width (in)	35.5	Yes	BlendTrans XSlope (%)	0.2
N/A	Flare Type LT	N/A	N/A	Flare Type RT	N/A
N/A	Flare Slope LT (%)	N/A	N/A	Flare Slope RT (%)	N/A
N/A	Flare Traversable LT?	N/A	N/A	Flare Traversable RT?	N/A
N/A	Landing Length (in)	N/A	N/A	DWS Provided?	N/A
N/A	Landing Width (in)	N/A	N/A	DWS Contrast?	N/A
N/A	Landing Slope (%)	N/A	N/A	DWS Length (in)	N/A
N/A	Landing X Slope (%)	N/A	N/A	DWS Full Width?	N/A
N/A	Landing Curb? (Y/N)	N/A	N/A	DWS Offset (in)	N/A
N/A	Shared Landing?	N/A			
N/A	Gutter Ponding?	N/A	N/A	Gutter Slope (%)	N/A
N/A	Gutter Lip Ht (in)	N/A	N/A	Gutter X Slope (%)	N/A
N/A	Painted X Walk1?	No	N/A	Painted X Walk2?	N/A
	X Walk 1 Direction	To NE		X Walk 2 Direction	N/A
	X Walk 1 Width (in)	N/A		X Walk 2 Width (in)	N/A
	X Walk 1 Slope (%)	0.1		X Walk 2 Slope (%)	N/A
	X Walk 1 X Slope (%)	2.3		X Walk 2 X Slope (%)	N/A

N/A	Ramp inside XWalk1?	N/A	N/A	Ramp inside XWalk2?	N/A
	Road Slope (%)	2.3		Clear Space?	N/A
	Road X Slope (%)	0.1	N/A	Clear Space to XWalk (in)	N/A
N/A	Any Obstructions?	N/A	N/A	Storm Grate/Utility Hazard?	N/A
	Obstruction Type			Storm Grate/Utility Type	
		N/A			N/A
			Yes	Surface Condition? (G/P)	Good
			N/A	Curb Slope (%)	2.7

Remove & Replace Curb Ramp With Two New Directional Ramps or Equivalent.
