Access Compliance Report

Public Rights-of-Way

(Curb Ramps)

Intersection ID: 12240	Main Street: ALLEN_ST	Cross Street: E_15TH_ST	Location: E
ADA ID: A018CCD33C6E	Ramp Type: BlendTrans1	Initial Pass/Fail: Fail	Overall Compliance: No
Severity Score: 10			
Codes/Mitigation Info/Possible Solution		Field Measurements/Component Compliance

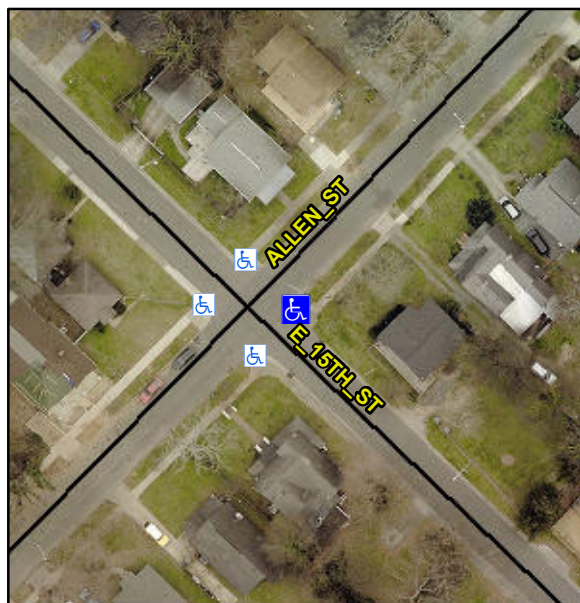
Not Found, R304.5.1, R304.5.3

Compliance	Description	Data	Compliance	Description	Data
N/A	Ramp Length (in)	74.0	Yes	BlendTrans Slope (%)	3.6
No	Ramp Width (in)	40.0	No	BlendTrans XSlope (%)	2.6
N/A	Flare Type LT	N/A	N/A	Flare Type RT	N/A
N/A	Flare Slope LT (%)	N/A	N/A	Flare Slope RT (%)	N/A
N/A	Flare Traversable LT?	N/A	N/A	Flare Traversable RT?	N/A
N/A	Landing Length (in)	N/A	N/A	DWS Provided?	N/A
N/A	Landing Width (in)	N/A	N/A	DWS Contrast?	N/A
N/A	Landing Slope (%)	N/A	N/A	DWS Length (in)	N/A
N/A	Landing X Slope (%)	N/A	N/A	DWS Full Width?	N/A
N/A	Landing Curb? (Y/N)	N/A	N/A	DWS Offset (in)	N/A
N/A	Shared Landing?	N/A			
N/A	Gutter Ponding?	Yes	N/A	Gutter Slope (%)	N/A
N/A	Gutter Lip Ht (in)	N/A	N/A	Gutter X Slope (%)	N/A
N/A	Painted X Walk1?	No	N/A	Painted X Walk2?	No
	X Walk 1 Direction	To NW		X Walk 2 Direction	To SW
	X Walk 1 Width (in)	N/A		X Walk 2 Width (in)	N/A
	X Walk 1 Slope (%)	3.7		X Walk 2 Slope (%)	0.2
	X Walk 1 X Slope (%)	3.0		X Walk 2 X Slope (%)	4.4

N/A	Ramp inside XWalk1?	N/A	N/A	Ramp inside XWalk2?	N/A
	Road Slope (%)	2.5		Clear Space?	N/A
	Road X Slope (%)	2.0	N/A	Clear Space to XWalk (in)	N/A
N/A	Any Obstructions?	N/A	N/A	Storm Grate/Utility Hazard?	N/A
	Obstruction Type			Storm Grate/Utility Type	
		N/A			N/A
		Yes		Surface Condition? (G/P)	Good
		No		Curb Slope (%)	19.0

Remove & Replace Curb Ramp With Two New Directional Ramps or Equivalent.
