Access Compliance Report

Public Rights-of-Way

(Curb Ramps)

Intersection ID: 13404	Main Street: LEXINGTON_AV	Cross Street: E_CARSON_BV	Location: SW
ADA ID: A01AFD349463	Ramp Type: Perp	Initial Pass/Fail: Fail	Overall Compliance: No
Severity Score: 13.75			
Codes/Mitigation Info/Possible Solution		Field Measurements/Component Compliance

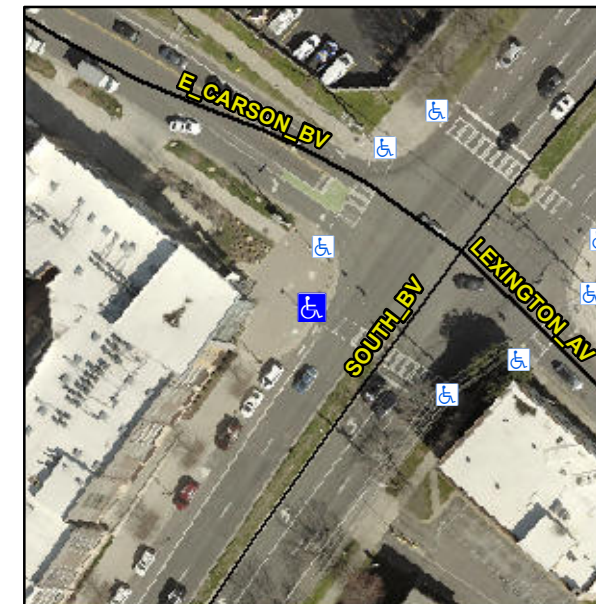
Not Found, R304.2.2, R304.5.3

Compliance	Description	Data	Compliance	Description	Data
N/A	Ramp Length (in)	95.0	No	Ramp Slope (%)	9.0
Yes	Ramp Width (in)	48.0	No	Ramp XSlope (%)	3.4
N/A	Flare Type LT	N/A	N/A	Flare Type RT	N/A
N/A	Flare Slope LT (%)	N/A	N/A	Flare Slope RT (%)	N/A
N/A	Flare Traversable LT?	N/A	N/A	Flare Traversable RT?	N/A
N/A	Landing Length (in)	N/A	N/A	DWS Provided?	N/A
N/A	Landing Width (in)	N/A	N/A	DWS Contrast?	N/A
N/A	Landing Slope (%)	N/A	N/A	DWS Length (in)	N/A
N/A	Landing X Slope (%)	N/A	N/A	DWS Full Width?	N/A
N/A	Landing Curb? (Y/N)	N/A	N/A	DWS Offset (in)	N/A
N/A	Shared Landing?	N/A			
N/A	Gutter Ponding?	N/A	N/A	Gutter Slope (%)	N/A
N/A	Gutter Lip Ht (in)	N/A	N/A	Gutter X Slope (%)	N/A
N/A	Painted X Walk1?	Yes	N/A	Painted X Walk2?	N/A
	X Walk 1 Direction	To SE		X Walk 2 Direction	N/A
N/A	X Walk 1 Width (in)	112.0	N/A	X Walk 2 Width (in)	N/A
	X Walk 1 Slope (%)	0.3		X Walk 2 Slope (%)	N/A
	X Walk 1 X Slope (%)	2.8		X Walk 2 X Slope (%)	N/A

N/A	Ramp inside XWalk1?	Yes	N/A	Ramp inside XWalk2?	N/A
	Road Slope (%)	N/A	N/A	Clear Space?	N/A
	Road X Slope (%)	N/A	N/A	Clear Space to XWalk (in)	N/A
N/A	Any Obstructions?	N/A	N/A	Storm Grate/Utility Hazard?	N/A
	Obstruction Type			Storm Grate/Utility Type	
		N/A			N/A
		Yes		Surface Condition? (G/P)	Good

Possible Solutions:

Remove & Replace Entire Ramp.

Total Cost: \$ 1850.00
