Access Compliance Report Public Rights-of-Way (Curb Ramps)

Intersection ID: 11418 Main Street: AIRLIE_ST Cross Street: HILLIARD_DR Location: N

ADA ID: A023E6E56EBF Ramp Type: Directional1 Initial Pass/Fail: Fail Overall Compliance: No Severity Score: 12.5

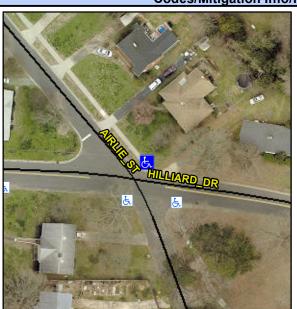
Field Measurements/Component Compliance								
Compliance Description		Data	Comp	liance	Description	Data		
N/A	Ramp Length (in)	79.5	N/A	Grade	e Break?	N/A		
Yes	Ramp Width (in)	55.0	N/A	Grade	e Break Slope (%)	0.0		
No	Ramp Slope (%)	9.5	N/A	Grade	e Break XSlope (%)	0.0		
Yes	Ramp XSlope (%)	1.8						
N/A	Flare Type LT	N/A	N/A	Flare	Type RT	N/A		
N/A	Flare Slope LT (%)	N/A	N/A	Flare	Slope RT (%)	0.0		
N/A	Flare Traversable LT?	N/A	N/A	Flare	Traversable RT?	N/A		
N/A	Landing Length (in)	0.0	N/A	DWS	Provided?	N/A		
N/A	Landing Width (in)	0.0	N/A	DWS	Contrast?	N/A		
N/A	Landing Slope (%)	0.0	N/A	DWS	Length (in)	N/A		
N/A	Landing X Slope (%)	0.0	N/A	DWS	Full Width?	N/A		
N/A	Landing Curb? (Y/N)	N/A	N/A	DWS	Offset LT (in)	N/A		
N/A	Shared Landing?	N/A	N/A	DWS	Offset RT (in)	N/A		
N/A	Gutter Ponding?	0.0	N/A	Gutte	r Slope (%)	N/A		
N/A	Gutter Lip Ht (in)	0.0	N/A	Gutte	r X Slope (%)	N/A		
N/A	Painted X Walk1?	No		Road	Slope (%)	3.6

X Walk 1 Direction	To SE		Road	X Slope (%)	3.8		
	X Walk 1 Width (in)	N/A		Clear	Space?	N/A		
	X Walk 1 Slope (%)	3.6	N/A	Clear	Space to XWalk (in)	N/A		
	X Walk 1 X Slope (%)	3.8	N/A	Storm	Grate/Utility Hazard?	N/A		
N/A	Ramp inside XWalk1?	N/A		Storm	Grate/Utility Type			
N/A	Any Obstructions?	N/A				N/A		
	Obstruction Type		Yes	Surfa	ce Condition? (G/P)	Good		
		N/A	N/A	Curb	Slope (%)	17.5

<u> </u>	i ossible solution
Sec. of	Possible Solutions:
A	Remove & Replace Entire Ramp.
	Surveyor Notes:
	N/A
10	PROW/ADA:
Sales Control of the last of t	R304.2.2
