Access Compliance Report

Public Rights-of-Way

(Curb Ramps)

Intersection ID: 9172	Main Street: E_CRAIGHEAD_RD	Cross Street: N_TRYON_ST	Location: NW
ADA ID: A026D5D638B0	Ramp Type: Perp	Initial Pass/Fail: Fail	Overall Compliance: No
Severity Score: 21.25			
Codes/Mitigation Info/Possible Solution		Field Measurements/Component Compliance

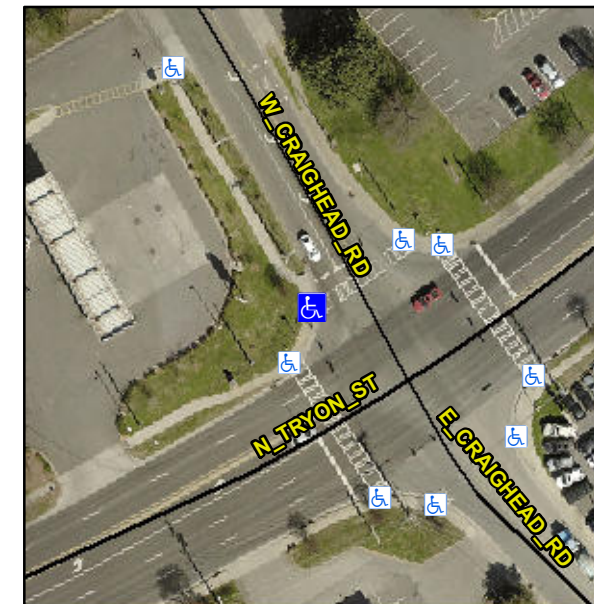
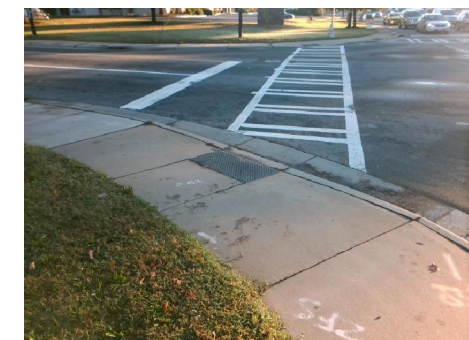
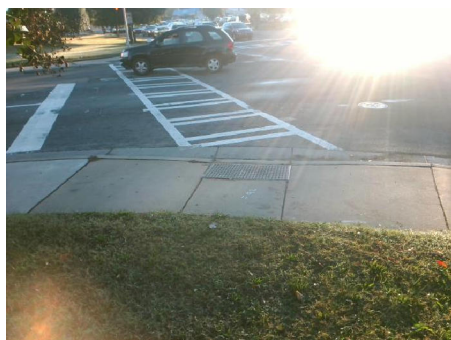
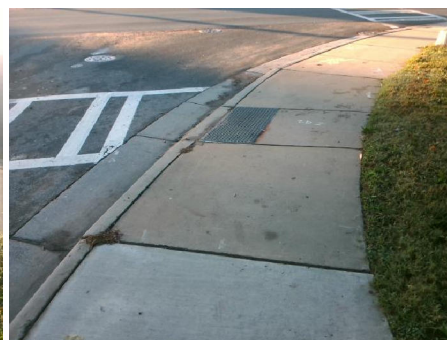
Not Found, R304.5.1, R304.2.2

Compliance	Description	Data	Compliance	Description	Data
N/A	Ramp Length (in)	71.5	No	Ramp Slope (%)	9.2
No	Ramp Width (in)	42.0	Yes	Ramp XSlope (%)	1.1
N/A	Flare Type LT	N/A	N/A	Flare Type RT	N/A
N/A	Flare Slope LT (%)	N/A	N/A	Flare Slope RT (%)	N/A
N/A	Flare Traversable LT?	N/A	N/A	Flare Traversable RT?	N/A
N/A	Landing Length (in)	N/A	N/A	DWS Provided?	N/A
N/A	Landing Width (in)	N/A	N/A	DWS Contrast?	N/A
N/A	Landing Slope (%)	N/A	N/A	DWS Length (in)	N/A
N/A	Landing X Slope (%)	N/A	N/A	DWS Full Width?	N/A
N/A	Landing Curb? (Y/N)	N/A	N/A	DWS Offset (in)	N/A
N/A	Shared Landing?	N/A			
N/A	Gutter Ponding?	N/A	N/A	Gutter Slope (%)	N/A
N/A	Gutter Lip Ht (in)	N/A	N/A	Gutter X Slope (%)	N/A
N/A	Painted X Walk1?	Yes	N/A	Painted X Walk2?	N/A
	X Walk 1 Direction	To NE		X Walk 2 Direction	N/A
N/A	X Walk 1 Width (in)	76.0	N/A	X Walk 2 Width (in)	N/A
	X Walk 1 Slope (%)	1.8		X Walk 2 Slope (%)	N/A
	X Walk 1 X Slope (%)	1.2		X Walk 2 X Slope (%)	N/A

N/A	Ramp inside XWalk1?	Yes	N/A	Ramp inside XWalk2?	N/A
	Road Slope (%)	N/A	N/A	Clear Space?	N/A
	Road X Slope (%)	N/A	N/A	Clear Space to XWalk (in)	N/A
N/A	Any Obstructions?	N/A	N/A	Storm Grate/Utility Hazard?	N/A
	Obstruction Type			Storm Grate/Utility Type	
		N/A			N/A
		Yes		Surface Condition? (G/P)	Good

Possible Solutions:

Remove & Replace Entire Ramp.
