Access Compliance Report

Public Rights-of-Way

(Curb Ramps)

| Intersection ID: 49269 | Main Street: GATEWOOD_OAKS_DR | Cross Street: PARK_RD | Location: SW |

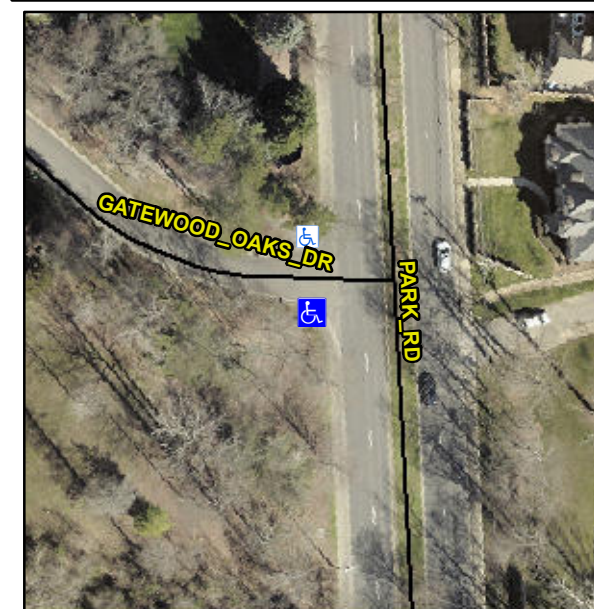
| ADA ID: A0281D9B2623 | Ramp Type: PerpDiag | Initial Pass/Fail: Fail | Overall Compliance: No |
| Severity Score: 21.25 | | | |

Not Found, R304.5.1, R304.5.3

| Compliance | Description | Data | Compliance | Description | Data |
|---|---|---|---|---|---|
| N/A | Ramp Length (in) | 60.0 | Yes | Ramp Slope (%) | 5.3 |
| No | Ramp Width (in) | 46.0 | No | Ramp XSlope (%) | 5.7 |

Remove & Replace Curb Ramp With Two New Directional Ramps or Equivalent.

Total Cost: \$ 3200.00
