Access Compliance Report Public Rights-of-Way (Curb Ramps)

Intersection ID: 46184 Main Street: GLOXINIA_RD Cross Street: NEEDLEPOINT_RD Location: NW

ADA ID: A029F1D7DC9E Ramp Type: Perp Initial Pass/Fail: Pass Overall Compliance: No Severity Score: 5

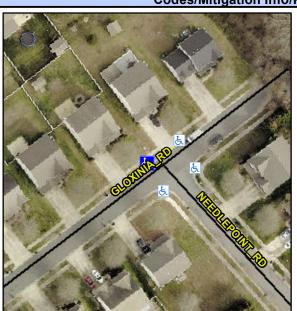
Field Measurements/Component Compliance					
Compliance Description		Data	Comp	liance Description	Data
N/A	Ramp Length (in)	60.0	Yes	Ramp Slope (%)	5.1
Yes	Ramp Width (in)	48.0	Yes	Ramp XSlope (%)	1.4
N/A	Flare Type LT	Sloped	N/A	Flare Type RT	N/A
N/A	Flare Slope LT (%)	4.9	N/A	Flare Slope RT (%)	2.1
N/A	Flare Traversable LT?	No	N/A	Flare Traversable RT?	No
No	Landing Length (in)	47.5	Yes	DWS Provided?	Yes
Yes	Landing Width (in)	48.0	Yes	DWS Contrast?	Yes
Yes	Landing Slope (%)	1.6	Yes	DWS Length (in)	24.0
Yes	Landing X Slope (%)	1.1	Yes	DWS Full Width?	Yes
N/A	Landing Curb? (Y/N)	No	No	DWS Offset (in)	6.0
N/A	Shared Landing?	No			
Yes	Gutter Ponding?	No	No	Gutter Slope (%)	11.2
Yes	Gutter Lip Ht (in)	0.0	Yes	Gutter X Slope (%)	1.0
N/A	Painted X Walk1?	No	N/A	Painted X Walk2?	N/A
	X Walk 1 Direction	To SE		X Walk 2 Direction	N/A
N/A	X Walk 1 Width (in)	N/A	N/A	X Walk 2 Width (in)	N/A
	X Walk 1 Slope (%)	4.8		X Walk 2 Slope (%)	N/A

X Walk 1 X Slope (%)	0.3		X Walk 2 X Slope (%)	N/A
N/A	Ramp inside XWalk1?	N/A	N/A	Ramp inside XWalk2?	N/A
	Road Slope (%)	N/A	N/A	Clear Space?	Yes
	Road X Slope (%)	N/A	N/A	Clear Space to XWalk (in)	N/A
Yes	Any Obstructions?	No	Yes	Storm Grate/Utility Hazard?	No
	Obstruction Type		l	Storm Grate/Utility Type	
		N/A			N/A
			I

Possible Solutions:

Remove & Replace Entire Ramp.
Remove & Replace Gutter.

Not Found, R304.2.1, R305.2,
R304.5.4
