Access Compliance Report

Public Rights-of-Way

(Curb Ramps)

Intersection ID: 10035065	Main Street: PROVIDENCE_RD	Cross Street: N/A	Location: SW
ADA ID: A03E1BE73DD7	Ramp Type: Directional1	Initial Pass/Fail: Fail	Overall Compliance: No
Severity Score: 12.5			
Codes/Mitigation Info/Possible Solution		Field Measurements/Component Compliance

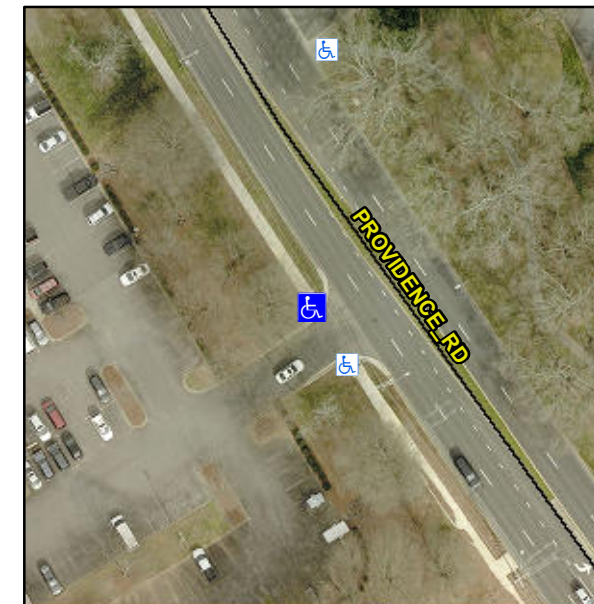
R304.2.2

Compliance	Description	Data	Compliance	Description	Data
N/A	Ramp Length (in)	93.0	N/A	Grade Break?	N/A
Yes	Ramp Width (in)	69.0	N/A	Grade Break Slope (%)	0.0
No	Ramp Slope (%)	9.5	N/A	Grade Break XSlope (%)	0.0
Yes	Ramp XSlope (%)	1.0			
N/A	Flare Type LT	N/A	N/A	Flare Type RT	N/A
N/A	Flare Slope LT (%)	N/A	N/A	Flare Slope RT (%)	0.0
N/A	Flare Traversable LT?	N/A	N/A	Flare Traversable RT?	N/A
N/A	Landing Length (in)	0.0	N/A	DWS Provided?	N/A
N/A	Landing Width (in)	0.0	N/A	DWS Contrast?	N/A
N/A	Landing Slope (%)	0.0	N/A	DWS Length (in)	N/A
N/A	Landing X Slope (%)	0.0	N/A	DWS Full Width?	N/A
N/A	Landing Curb? (Y/N)	N/A	N/A	DWS Offset LT (in)	N/A
N/A	Shared Landing?	N/A	N/A	DWS Offset RT (in)	N/A
N/A	Gutter Ponding?	0.0	N/A	Gutter Slope (%)	N/A
N/A	Gutter Lip Ht (in)	0.0	N/A	Gutter X Slope (%)	N/A
N/A	Painted X Walk1?	No		Road Slope (%)	2.0
	X Walk 1 Direction	To SE		Road X Slope (%)	8.1
	X Walk 1 Width (in)	N/A		Clear Space?	N/A

X Walk 1 Slope (%)	2.0	N/A	Clear Space to XWalk (in)	N/A
	X Walk 1 X Slope (%)	8.1	N/A	Storm Grate/Utility Hazard?	N/A
N/A	Ramp inside XWalk1?	N/A		Storm Grate/Utility Type	
N/A	Any Obstructions?	N/A			N/A
	Obstruction Type		Yes	Surface Condition? (G/P)	Good
			N/A	Curb Slope (%)	2.6

Possible Solutions:

Remove & Replace Entire Ramp.
