Access Compliance Report Public Rights-of-Way (Curb Ramps)

Intersection ID: 6882 Main Street: STATESVILLE RD **Cross Street: CINDY_LN** Location: SW **Overall Compliance: No** ADA ID: A043D39E4227 Ramp Type: Para Initial Pass/Fail: Fail Severity Score: 13.75

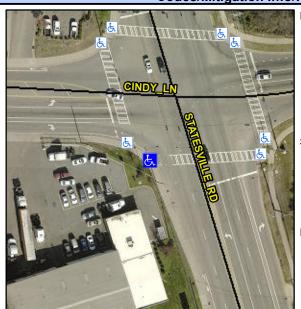
Possible Solutions:	Co
Remove & Replace Entire Ramp.	N/A
·	Ye
	No
	Ye
	N/A
	N/A
Surveyor Notes:	N/A
CURB GAP 1.0	N/A
	N/A
	N/A
	N/A
PROW/ADA:	N/A
R304.3.2, R304.5.3	N/A
	N/A
	N/A

Data	liance Description	Comp	Data	liance Description	Comp
60.0	Ramp Length RT (in)	N/A	62.0	Ramp Length LT (in)	N/A
84.0	Ramp Width RT (in)	Yes	85.5	Ramp Width LT (in)	Yes

7.9	Ramp Slope RT (%)	Yes	8.8	Ramp Slope LT (%)	No
2.4	Ramp XSlope RT (%)	No	1.5	Ramp XSlope LT (%)	Yes
N/A	DWS Provided?	N/A	N/A	Landing Length (in)	N/A
N/A	DWS Contrast?	N/A	N/A	Landing Width (in)	N/A
N/A	DWS Length (in)	N/A	N/A	Landing Slope (%)	N/A
N/A	DWS Full Width?	N/A	N/A	Landing X Slope (%)	N/A
N/A	DWS Offset (in)	N/A	N/A	Landing Curb? (Y/N)	N/A
			N/A	Shared Landing?	N/A
N/A	Gutter Slope (%)	N/A	N/A	Gutter Ponding?	N/A
N/A	Gutter X Slope (%)	N/A	N/A	Gutter Lip Ht (in)	N/A
N/A	Painted X Walk2?	N/A	Yes	Painted X Walk1?	N/A
N/A	X Walk 2 Direction		То Е	X Walk 1 Direction	
N/A	X Walk 2 Width (in)	N/A	116.0	X Walk 1 Width (in)	N/A
N/A	X Walk 2 Slope (%)		4.9	X Walk 1 Slope (%)	
N/A	X Walk 2 X Slope (%)		0.7	X Walk 1 X Slope (%)	
N/A	Ramp inside XWalk2?	N/A	Yes	Ramp inside XWalk1?	N/A
N/A	Clear Space?	N/A	N/A	Road Slope (%)	
N/A	Clear Space to XWalk (in)	N/A	N/A	Road X Slope (%)	
N/A	Storm Grate/Utility Hazard?	N/A	N/A	Any Obstructions?	N/A
