# Access Compliance Report

## Public Rights-of-Way

### (Curb Ramps)

Intersection ID: 10317	Main Street: E_32ND_ST	Cross Street: N_DAVIDSON_ST	Location: S
ADA ID: A053A78B0607	Ramp Type: Directional1	Initial Pass/Fail: Fail	Overall Compliance: No
		Severity Score: 8.75

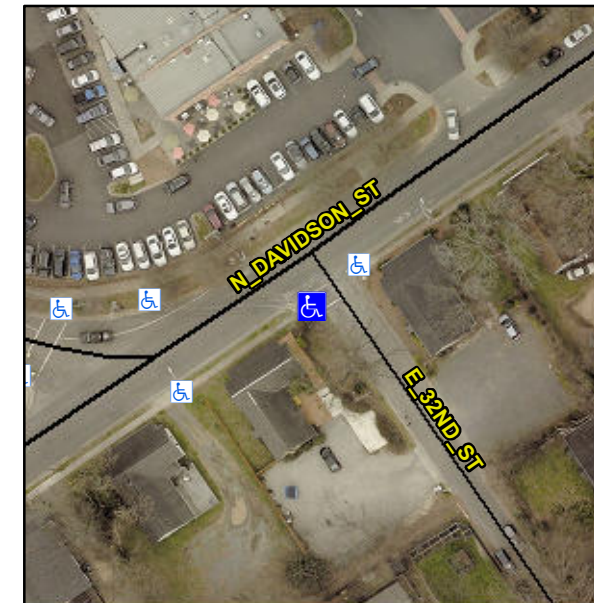
Compliance	Description	Data	Compliance	Description	Data
N/A	Ramp Length (in)	81.0	N/A	Grade Break?	N/A
No	Ramp Width (in)	47.0	N/A	Grade Break Slope (%)	0.0
Yes	Ramp Slope (%)	5.2	N/A	Grade Break XSlope (%)	0.0
Yes	Ramp XSlope (%)	1.7			
N/A	Flare Type LT	N/A	N/A	Flare Type RT	N/A
N/A	Flare Slope LT (%)	N/A	N/A	Flare Slope RT (%)	0.0
N/A	Flare Traversable LT?	N/A	N/A	Flare Traversable RT?	N/A
N/A	Landing Length (in)	0.0	N/A	DWS Provided?	N/A
N/A	Landing Width (in)	0.0	N/A	DWS Contrast?	N/A
N/A	Landing Slope (%)	0.0	N/A	DWS Length (in)	N/A
N/A	Landing X Slope (%)	0.0	N/A	DWS Full Width?	N/A
N/A	Landing Curb? (Y/N)	N/A	N/A	DWS Offset LT (in)	N/A
N/A	Shared Landing?	N/A	N/A	DWS Offset RT (in)	N/A
N/A	Gutter Ponding?	0.0	N/A	Gutter Slope (%)	N/A
N/A	Gutter Lip Ht (in)	0.0	N/A	Gutter X Slope (%)	N/A
N/A	Painted X Walk1?	Yes		Road Slope (%)	2.1
	X Walk 1 Direction	To NE		Road X Slope (%)	0.5
	X Walk 1 Width (in)	108.0		Clear Space?	N/A

X Walk 1 Slope (%)	2.1	N/A	Clear Space to XWalk (in)	N/A
	X Walk 1 X Slope (%)	0.5	N/A	Storm Grate/Utility Hazard?	N/A
N/A	Ramp inside XWalk1?	Yes		Storm Grate/Utility Type	
N/A	Any Obstructions?	N/A			N/A
	Obstruction Type		Yes	Surface Condition? (G/P)	Good
			N/A	Curb Slope (%)	21.1

**Remove & Replace Entire Ramp.**

**R304.5.1**

\$ 1600.00
