# Access Compliance Report

## Public Rights-of-Way

### (Curb Ramps)

Intersection ID: 3717	Main Street: CLAIBORNE_WOODS_RD	Cross Street: PALOMINO_CT	Location:	N
ADA ID: A0553C205BDB	Ramp Type: Perp	Initial Pass/Fail: Fail	Overall Compliance: No	Severity Score: 10
Codes/Mitigation Info/Possible Solution		Field Measurements/Component Compliance

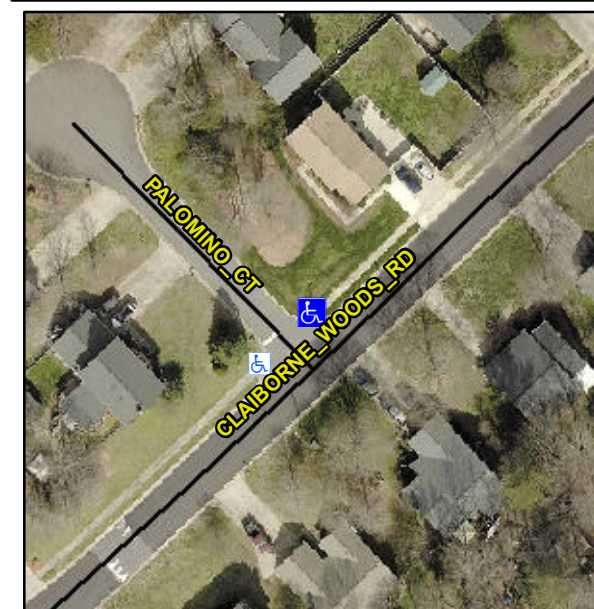
**Not Found, R304.5.1, R304.5.3**

Compliance	Description	Data	Compliance	Description	Data
N/A	Ramp Length (in)	31.0	Yes	Ramp Slope (%)	5.0
No	Ramp Width (in)	47.5	No	Ramp XSlope (%)	2.2
N/A	Flare Type LT	N/A	N/A	Flare Type RT	N/A
N/A	Flare Slope LT (%)	N/A	N/A	Flare Slope RT (%)	N/A
N/A	Flare Traversable LT?	N/A	N/A	Flare Traversable RT?	N/A
N/A	Landing Length (in)	N/A	N/A	DWS Provided?	N/A
N/A	Landing Width (in)	N/A	N/A	DWS Contrast?	N/A
N/A	Landing Slope (%)	N/A	N/A	DWS Length (in)	N/A
N/A	Landing X Slope (%)	N/A	N/A	DWS Full Width?	N/A
N/A	Landing Curb? (Y/N)	N/A	N/A	DWS Offset (in)	N/A
N/A	Shared Landing?	N/A			
N/A	Gutter Ponding?	N/A	N/A	Gutter Slope (%)	N/A
N/A	Gutter Lip Ht (in)	N/A	N/A	Gutter X Slope (%)	N/A
N/A	Painted X Walk1?	No	N/A	Painted X Walk2?	N/A
	X Walk 1 Direction	To SW		X Walk 2 Direction	N/A
N/A	X Walk 1 Width (in)	N/A	N/A	X Walk 2 Width (in)	N/A
	X Walk 1 Slope (%)	2.2		X Walk 2 Slope (%)	N/A
	X Walk 1 X Slope (%)	0.5		X Walk 2 X Slope (%)	N/A

N/A	Ramp inside XWalk1?	N/A	N/A	Ramp inside XWalk2?	N/A
	Road Slope (%)	N/A	N/A	Clear Space?	N/A
	Road X Slope (%)	N/A	N/A	Clear Space to XWalk (in)	N/A
N/A	Any Obstructions?	N/A	N/A	Storm Grate/Utility Hazard?	N/A
	Obstruction Type			Storm Grate/Utility Type	
		N/A			N/A
			Yes	Surface Condition? (G/P)	Good

**Remove & Replace Entire Ramp.**

Total Cost: \$ 1850.00
