## Access Compliance Report Public Rights-of-Way (Curb Ramps)

Intersection ID: 43098Main Street: HOPEDALE\_AVCross Street: QUEENS\_RD\_WESTLocation:NEADA ID: A0604254B8B6Ramp Type: PerpInitial Pass/Fail: FailOverall Compliance: NoSeverity Score: 26.25

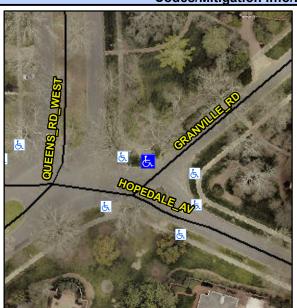
Compliance Description		Data		iance Description	Data
N/A	Ramp Length (in)	72.0	No	Ramp Slope (%)	12.9
Yes	Ramp Width (in)	48.0	No	No Ramp XSlope (%)	
N/A	Flare Type LT	N/A	N/A	Flare Type RT	N/A
N/A	Flare Slope LT (%)	N/A	N/A	Flare Slope RT (%)	N/A
N/A	Flare Traversable LT?	N/A	N/A	Flare Traversable RT?	N/A
N/A	Landing Length (in)	N/A	N/A	DWS Provided?	N/A
N/A	Landing Width (in)	N/A	N/A	DWS Contrast?	N/A
N/A	Landing Slope (%)	N/A	N/A	DWS Length (in)	N/A
N/A	Landing X Slope (%)	N/A	N/A	DWS Full Width?	N/A
N/A	Landing Curb? (Y/N)	N/A	N/A	DWS Offset (in)	N/A
N/A	Shared Landing?	N/A			
N/A	Gutter Ponding?	N/A	N/A	Gutter Slope (%)	N/A
N/A	Gutter Lip Ht (in)	N/A	N/A	Gutter X Slope (%)	N/A
N/A	Painted X Walk1?	No	N/A	Painted X Walk2?	N/A
	X Walk 1 Direction	To SE		X Walk 2 Direction	N/A
N/A	X Walk 1 Width (in)	N/A	N/A	X Walk 2 Width (in)	N/A
	X Walk 1 Slope (%)	7.9		X Walk 2 Slope (%)	N/A
	X Walk 1 X Slope (%)	1.5		X Walk 2 X Slope (%)	N/A

N/A	Ramp inside XWalk1?	N/A	N/A	Ramp inside XWalk2?	N/A
	Road Slope (%)	N/A	N/A	Clear Space?	N/A
	Road X Slope (%)	N/A	N/A	Clear Space to XWalk (in)	N/A
N/A	Any Obstructions?	N/A	N/A	Storm Grate/Utility Hazard?	N/A
	Obstruction Type		l	Storm Grate/Utility Type	
		N/A			N/A
			Yes	Surface Condition? (G/P)	Good

Possible Solutions:	
Remove & Replace Entire Ramp.	ı
	•
	ı
	ı
	ı
	l
Surveyor Notes:	
N/A	
	l
PROW/ADA:	
Not Found, R304.2.2, R304.5.3
