# Access Compliance Report

## Public Rights-of-Way

### (Curb Ramps)

Intersection ID: 21519	Main Street: AMYINGTON_DR	Cross Street: COLONY_RD	Location: S
ADA ID: A06B14E092F1	Ramp Type: Perp	Initial Pass/Fail: Fail	Overall Compliance: No
		Severity Score: 30

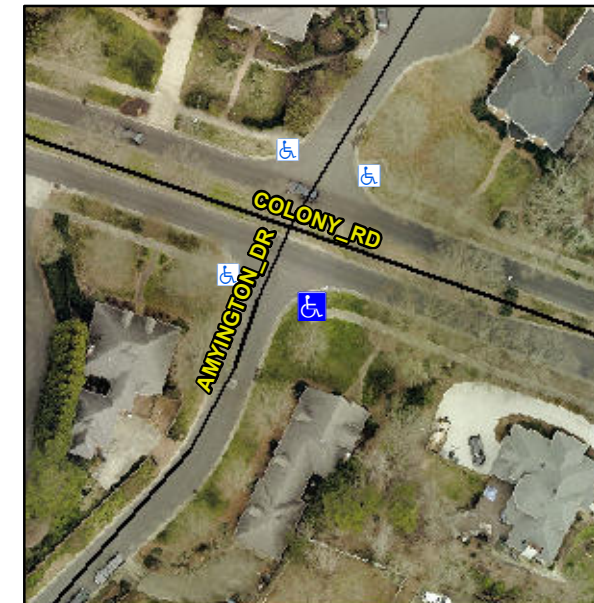
**Not Found, R304.5.1, R304.5.3**

Compliance	Description	Data	Compliance	Description	Data
N/A	Ramp Length (in)	105.0	Yes	Ramp Slope (%)	5.1
No	Ramp Width (in)	33.0	No	Ramp XSlope (%)	6.1
N/A	Flare Type LT	N/A	N/A	Flare Type RT	N/A
N/A	Flare Slope LT (%)	N/A	N/A	Flare Slope RT (%)	N/A
N/A	Flare Traversable LT?	N/A	N/A	Flare Traversable RT?	N/A
N/A	Landing Length (in)	N/A	N/A	DWS Provided?	N/A
N/A	Landing Width (in)	N/A	N/A	DWS Contrast?	N/A
N/A	Landing Slope (%)	N/A	N/A	DWS Length (in)	N/A
N/A	Landing X Slope (%)	N/A	N/A	DWS Full Width?	N/A
N/A	Landing Curb? (Y/N)	N/A	N/A	DWS Offset (in)	N/A
N/A	Shared Landing?	N/A			
N/A	Gutter Ponding?	N/A	N/A	Gutter Slope (%)	N/A
N/A	Gutter Lip Ht (in)	N/A	N/A	Gutter X Slope (%)	N/A
N/A	Painted X Walk1?	No	N/A	Painted X Walk2?	N/A
	X Walk 1 Direction	To NW		X Walk 2 Direction	N/A
N/A	X Walk 1 Width (in)	N/A	N/A	X Walk 2 Width (in)	N/A
	X Walk 1 Slope (%)	6.2		X Walk 2 Slope (%)	N/A
	X Walk 1 X Slope (%)	1.9		X Walk 2 X Slope (%)	N/A

N/A	Ramp inside XWalk1?	N/A	N/A	Ramp inside XWalk2?	N/A
	Road Slope (%)	N/A	N/A	Clear Space?	N/A
	Road X Slope (%)	N/A	N/A	Clear Space to XWalk (in)	N/A
N/A	Any Obstructions?	N/A	N/A	Storm Grate/Utility Hazard?	N/A
	Obstruction Type			Storm Grate/Utility Type	
		N/A			N/A
			Yes	Surface Condition? (G/P)	Good

**Remove & Replace Entire Ramp.**
