# Access Compliance Report

## Public Rights-of-Way

### (Curb Ramps)

| Intersection ID: 15882 | Main Street: EAST_BV | Cross Street: QUEENS_RD_WEST | Location: SE |

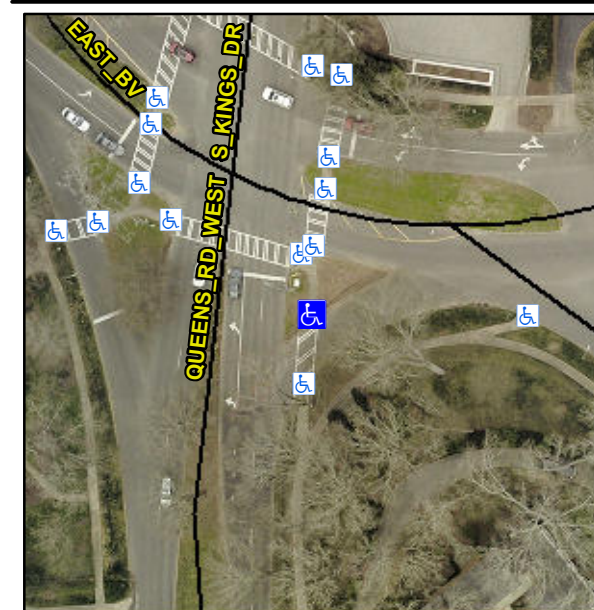
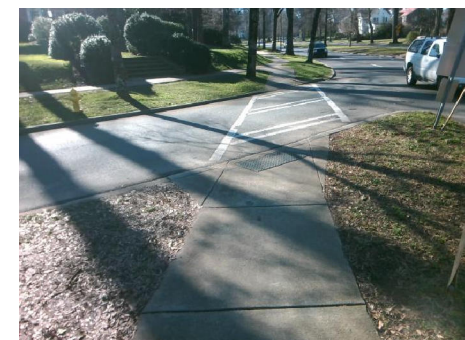
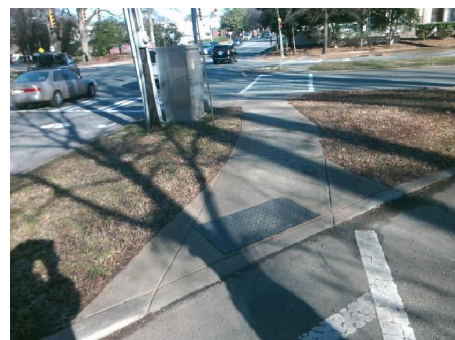
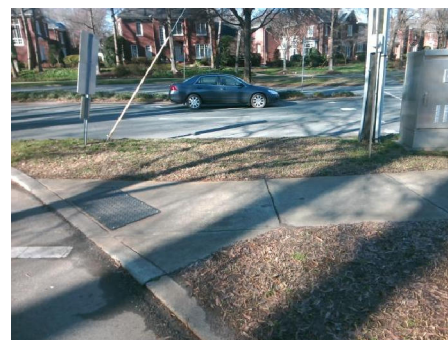
| ADA ID: A07A3455959F | Ramp Type: BlendTrans1 | Initial Pass/Fail: Pass | Overall Compliance: No |

**R304.5.3, R305.1.4**

| Compliance | Description | Data | Compliance | Description | Data |
|---|---|---|---|---|---|
| Yes | Ramp Width (in) | 59.0 | No | BlendTrans XSlope (%) | 2.8 |
| Yes | Landing X Slope (%) | 1.0 | No | DWS Full Width? | No |
| Yes | Gutter Lip Ht (in) | 0.0 | No | Gutter X Slope (%) | 2.2 |

**Remove & Replace Curb Ramp With Two New Directional Ramps or Equivalent. Remove & Replace Gutter.**
