Access Compliance Report Public Rights-of-Way (Curb Ramps)

Intersection ID: 11650 Main Street: W_10TH_ST Cross Street: N_CHURCH_ST Location: N

ADA ID: A07D1C5B6C5B Ramp Type: BlendTrans1 Initial Pass/Fail: Pass Overall Compliance: No Severity Score: 2.5

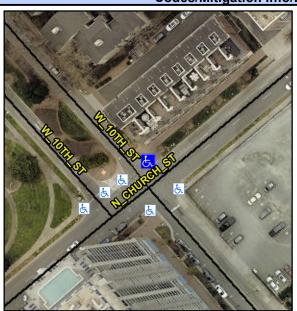
POSSIBLE SOLUTION	
Possible Solutions:	
Remove & Replace Detectable Warning System.	
Surveyor Notes:	
DAMAGED CURB	
PROW/ADA:	
R305.1.4

N/A	Flare Traversable LT?	Yes	N/A	Flare Traversable RT?	No
Yes	Landing Length (in)	60.0	Yes	DWS Provided?	Yes
Yes	Landing Width (in)	60.0	Yes	DWS Contrast?	Yes
Yes	Landing Slope (%)	0.2	Yes	DWS Length (in)	24.0
Yes	Landing X Slope (%)	0.4	No	DWS Full Width?	No
N/A	Landing Curb? (Y/N)	No	Yes	DWS Offset (in)	0.0
N/A	Shared Landing?	No			
Yes	Gutter Ponding?	No	Yes	Gutter Slope (%)	4.5
Yes	Gutter Lip Ht (in)	0.0	Yes	Gutter X Slope (%)	0.7
N/A	Painted X Walk1?	No	N/A	Painted X Walk2?	No
	X Walk 1 Direction	To SW		X Walk 2 Direction	To SE
	X Walk 1 Width (in)	N/A		X Walk 2 Width (in)	N/A
	X Walk 1 Slope (%)	8.5		X Walk 2 Slope (%)	5.9
	X Walk 1 X Slope (%)	5.5		X Walk 2 X Slope (%)	3.0
N/A	Ramp inside XWalk1?	N/A	N/A	Ramp inside XWalk2?	N/A
	Road Slope (%)	2.6		Clear Space?	Yes
	Road X Slope (%)	12.7	N/A	Clear Space to XWalk (in)	N/A
Yes	Any Obstructions?	No	Yes	Storm Grate/Utility Hazard?	No
	Obstruction Type			Storm Grate/Utility Type
