Access Compliance Report

Public Rights-of-Way

(Curb Ramps)

Intersection ID: 13086	Main Street: CENTRAL_AV	Cross Street: CLEMENT_AV	Location: NW
ADA ID: A08E156E938C	Ramp Type: Directional1	Initial Pass/Fail: Fail	Overall Compliance: No
Severity Score: 12.5

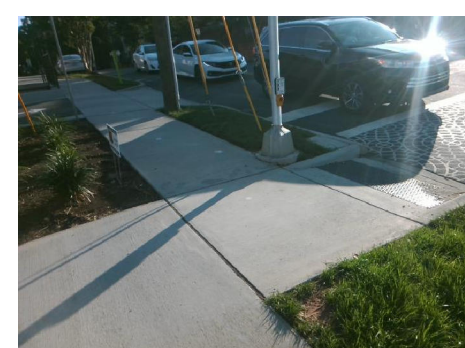
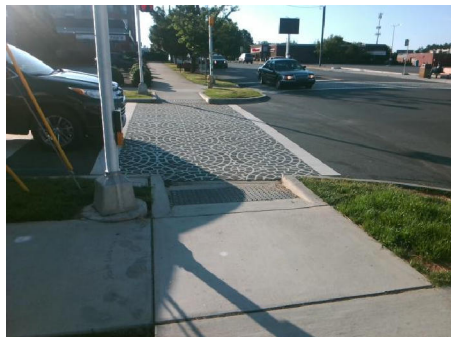
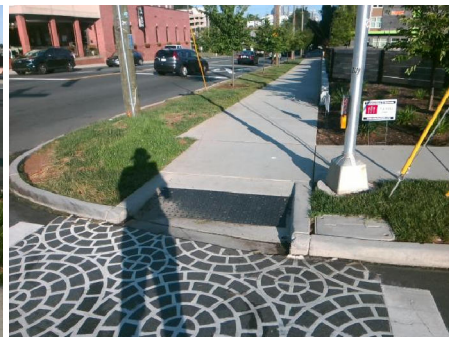
Compliance	Description	Data	Compliance	Description	Data
N/A	Ramp Length (in)	43.0	N/A	Grade Break?	N/A
Yes	Ramp Width (in)	62.0	N/A	Grade Break Slope (%)	0.0
No	Ramp Slope (%)	9.9	N/A	Grade Break XSlope (%)	0.0
Yes	Ramp XSlope (%)	1.5			
N/A	Flare Type LT	N/A	N/A	Flare Type RT	N/A
N/A	Flare Slope LT (%)	N/A	N/A	Flare Slope RT (%)	0.0
N/A	Flare Traversable LT?	N/A	N/A	Flare Traversable RT?	N/A
N/A	Landing Length (in)	0.0	N/A	DWS Provided?	N/A
N/A	Landing Width (in)	0.0	N/A	DWS Contrast?	N/A
N/A	Landing Slope (%)	0.0	N/A	DWS Length (in)	N/A
N/A	Landing X Slope (%)	0.0	N/A	DWS Full Width?	N/A
N/A	Landing Curb? (Y/N)	N/A	N/A	DWS Offset LT (in)	N/A
N/A	Shared Landing?	N/A	N/A	DWS Offset RT (in)	N/A
N/A	Gutter Ponding?	0.0	N/A	Gutter Slope (%)	N/A
N/A	Gutter Lip Ht (in)	0.0	N/A	Gutter X Slope (%)	N/A
N/A	Painted X Walk1?	Yes		Road Slope (%)	6.7
	X Walk 1 Direction	To E		Road X Slope (%)	3.6
	X Walk 1 Width (in)	121.0		Clear Space?	N/A

X Walk 1 Slope (%)	6.7	N/A	Clear Space to XWalk (in)	N/A
	X Walk 1 X Slope (%)	3.6	N/A	Storm Grate/Utility Hazard?	N/A
N/A	Ramp inside XWalk1?	Yes		Storm Grate/Utility Type	
N/A	Any Obstructions?	N/A			N/A
	Obstruction Type		Yes	Surface Condition? (G/P)	Good
			N/A	Curb Slope (%)	0.3

Remove & Replace Entire Ramp.
