Access Compliance Report

Public Rights-of-Way

(Curb Ramps)

Intersection ID: 15882	Main Street: EAST_BV	Cross Street: QUEENS_RD_WEST	Location: SE
ADA ID: A096D79447F3	Ramp Type: PerpDiag	Initial Pass/Fail: Fail	Overall Compliance: No
		Severity Score: 33.75

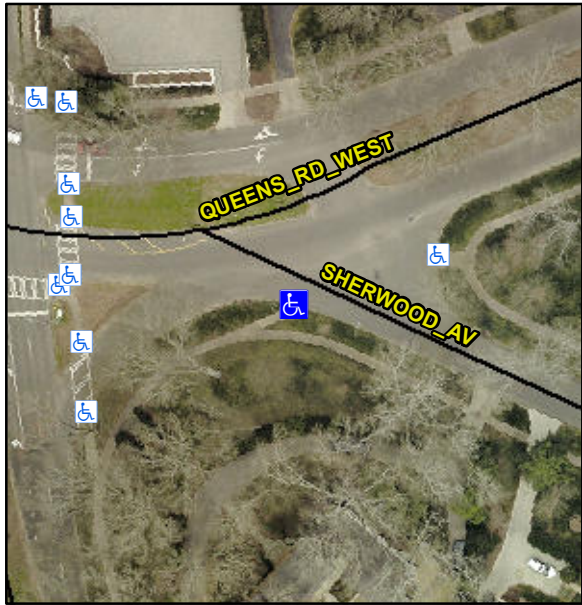
Possible Solutions:	Remove & Replace Curb Ramp With Two New Directional Ramps or Equivalent.		Compliance	Description	Data	Compliance	Description	Data
				N/A	Ramp Length (in)	102.0	No	Ramp Slope (%)	9.1
				No	Ramp Width (in)	44.0	No	Ramp XSlope (%)	5.1
				N/A	Flare Type LT	N/A	N/A	Flare Type RT	N/A
				N/A	Flare Slope LT (%)	N/A	N/A	Flare Slope RT (%)	N/A
				N/A	Flare Traversable LT?	N/A	N/A	Flare Traversable RT?	N/A
				N/A	Landing Length (in)	N/A	N/A	DWS Provided?	N/A
				N/A	Landing Width (in)	N/A	N/A	DWS Contrast?	N/A
				N/A	Landing Slope (%)	N/A	N/A	DWS Length (in)	N/A
				N/A	Landing X Slope (%)	N/A	N/A	DWS Full Width?	N/A
	Surveyor Notes:	N/A		N/A	Landing Curb? (Y/N)	N/A	N/A	DWS Offset (in)	N/A
	PROW/ADA:	R304.5.1, R304.2.2, R304.5.3		N/A	Shared Landing?	N/A			
				N/A	Gutter Ponding?	N/A	N/A	Gutter Slope (%)	N/A

N/A	Gutter Lip Ht (in)	N/A	N/A	Gutter X Slope (%)	N/A
				N/A	Painted X Walk1?	No	N/A	Painted X Walk2?	No
					X Walk 1 Direction	To E		X Walk 2 Direction	To N
				N/A	X Walk 1 Width (in)	N/A	N/A	X Walk 2 Width (in)	N/A
					X Walk 1 Slope (%)	5.3		X Walk 2 Slope (%)	4.3
					X Walk 1 X Slope (%)	3.1		X Walk 2 X Slope (%)	5.4
				N/A	Ramp inside XWalk1?	N/A	N/A	Ramp inside XWalk2?	N/A
					Road Slope (%)	3.8	N/A	Clear Space?	N/A
					Road X Slope (%)	4.0	N/A	Clear Space to XWalk (in)	N/A
				N/A	Any Obstructions?	N/A	N/A	Storm Grate/Utility Hazard?	N/A
					Obstruction Type			Storm Grate/Utility Type	
						N/A			N/A
							Yes	Surface Condition? (G/P)	Good
Total Cost:		\$	3200.00
