Access Compliance Report Public Rights-of-Way (Curb Ramps)

Intersection ID: N/A Main Street: BEVERLY CREST BV Cross Street: N/A Location: Initial Pass/Fail: Fail **Overall Compliance: No** ADA ID: A0991D746918 Ramp Type: PerpDiag Severity Score: 13.75

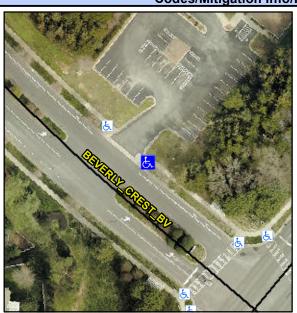
Yes Ramp XSlope (%) Yes Ramp Width (in) 48.0 N/A N/A Flare Type LT N/A Flare Type RT N/A N/A N/A Flare Slope RT (%) Flare Slope LT (%) N/A Flare Traversable LT? N/A N/A Flare Traversable RT? N/A N/A N/A **DWS Provided?** Landing Length (in) N/A Landing Width (in) N/A N/A **DWS Contrast?** N/A N/A N/A Landing Slope (%) DWS Length (in) N/A Landing X Slope (%) N/A N/A DWS Full Width? N/A Landing Curb? (Y/N) N/A N/A DWS Offset (in) N/A N/A Shared Landing? N/A **Gutter Ponding?** N/A N/A Gutter Slope (%) N/A Gutter Lip Ht (in) N/A N/A Gutter X Slope (%) N/A Painted X Walk1? No N/A Painted X Walk2? X Walk 1 Direction To NW X Walk 2 Direction N/A N/A X Walk 1 Width (in) X Walk 2 Width (in) X Walk 1 Slope (%) X Walk 2 Slope (%) 4.4 X Walk 1 X Slope (%) 7.1 X Walk 2 X Slope (%) N/A N/A N/A Ramp inside XWalk2? Ramp inside XWalk1? Road Slope (%) 3.0 N/A Clear Space? N/A Road X Slope (%) 7.5 Clear Space to XWalk (in) N/A N/A N/A Any Obstructions? Storm Grate/Utility Hazard? **Obstruction Type** Storm Grate/Utility Type N/A

ENTRANCE Street 1 Name Stop Condition-Street 2 None **BEVERLY CREST BV** Street 2 Name Stop Condition-Street 1 None Possible Solutions: Remove & Replace Curb Ramp With Two New Directional Ramps or Equivalent. Surveyor Notes: N/A PROW/ADA: R304.2.2

Total Cost: 3200.00
