# Access Compliance Report

## Public Rights-of-Way

### (Curb Ramps)

Intersection ID: 24195	Main Street: PROVIDENCE_RD	Cross Street: BEVERLY_CREST_BV	Location: NE
ADA ID: A0A0CBB94BA1	Ramp Type: Perp	Initial Pass/Fail: Fail	Overall Compliance: No
Severity Score: 21.25			
Codes/Mitigation Info/Possible Solution		Field Measurements/Component Compliance

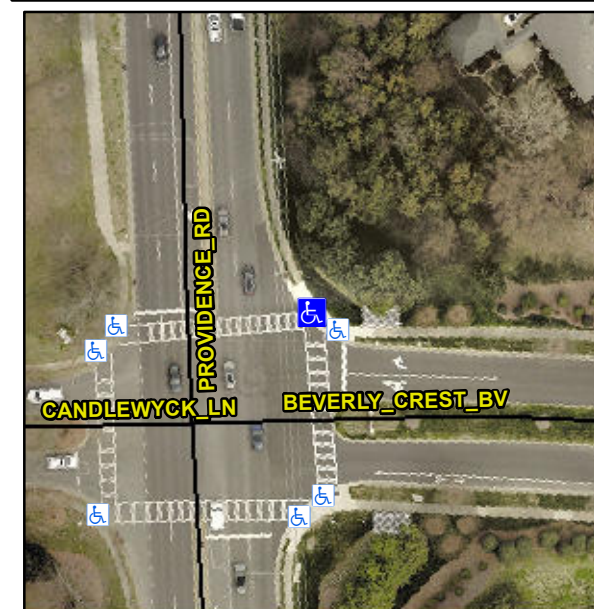
**Not Found, R304.5.1, R304.5.3**

Compliance	Description	Data	Compliance	Description	Data
N/A	Ramp Length (in)	75.0	Yes	Ramp Slope (%)	6.9
No	Ramp Width (in)	39.0	No	Ramp XSlope (%)	6.7
N/A	Flare Type LT	N/A	N/A	Flare Type RT	N/A
N/A	Flare Slope LT (%)	N/A	N/A	Flare Slope RT (%)	N/A
N/A	Flare Traversable LT?	N/A	N/A	Flare Traversable RT?	N/A
N/A	Landing Length (in)	N/A	N/A	DWS Provided?	N/A
N/A	Landing Width (in)	N/A	N/A	DWS Contrast?	N/A
N/A	Landing Slope (%)	N/A	N/A	DWS Length (in)	N/A
N/A	Landing X Slope (%)	N/A	N/A	DWS Full Width?	N/A
N/A	Landing Curb? (Y/N)	N/A	N/A	DWS Offset (in)	N/A
N/A	Shared Landing?	N/A			
N/A	Gutter Ponding?	N/A	N/A	Gutter Slope (%)	N/A
N/A	Gutter Lip Ht (in)	N/A	N/A	Gutter X Slope (%)	N/A
N/A	Painted X Walk1?	Yes	N/A	Painted X Walk2?	N/A
	X Walk 1 Direction	To NW		X Walk 2 Direction	N/A
N/A	X Walk 1 Width (in)	85.0	N/A	X Walk 2 Width (in)	N/A
	X Walk 1 Slope (%)	4.0		X Walk 2 Slope (%)	N/A
	X Walk 1 X Slope (%)	2.1		X Walk 2 X Slope (%)	N/A

**Remove & Replace Entire Ramp.**

Total Cost: \$ 1850.00
