| Intersection ID: 49450 | Main Street: MARICOPA_RD | Cross Street: ALVARADO_WY | Location: | NE |
| ADA ID: A0ADA6171E32 | Ramp Type: BlendTrans1 | Initial Pass/Fail: Fail | Overall Compliance: No | Severity Score: 8.75 |

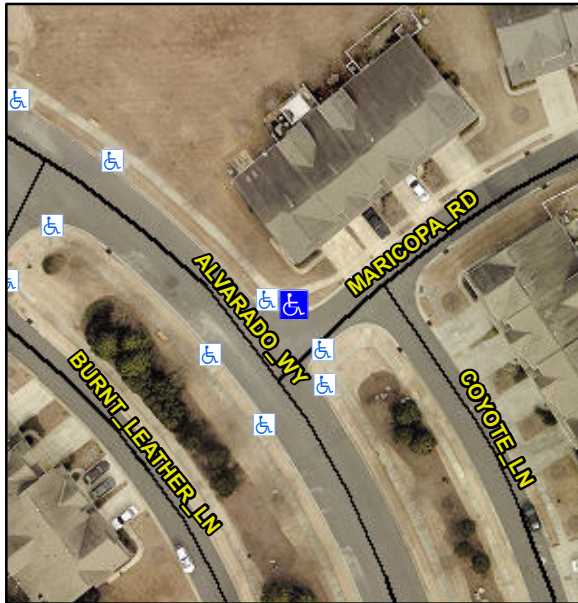
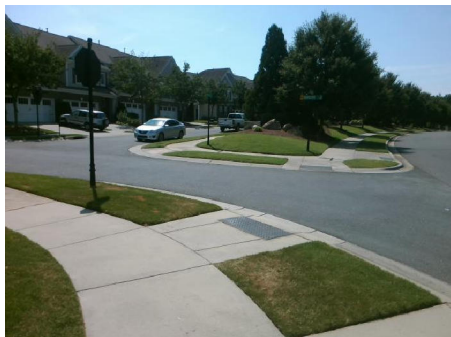
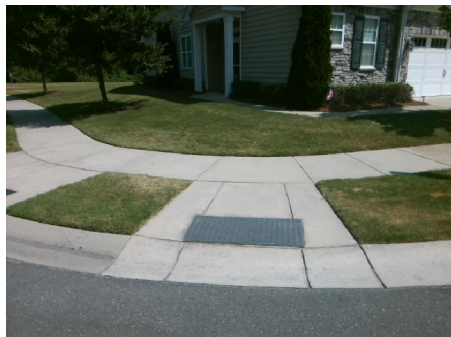
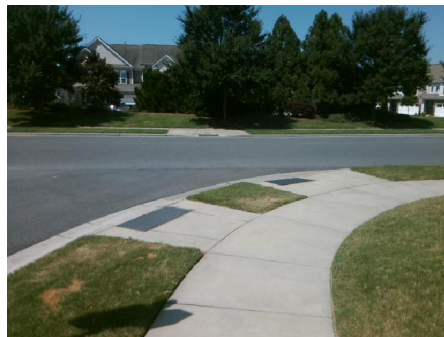
### R304.5.1

| Compliance | Description | Data | Compliance | Description | Data |
|---|---|---|---|---|---|
| No | Ramp Width (in) | 36.0 | Yes | BlendTrans XSlope (%) | 1.5 |

**Remove & Replace Curb Ramp With Two New Directional Ramps or Equivalent.**

Total Cost: \$ 3200.00
