Access Compliance Report

Public Rights-of-Way

(Curb Ramps)

| Intersection ID: 50523 | Main Street: SHEFFINGDELL_DR | Cross Street: JASMIN_MAY_DR | Location: E |

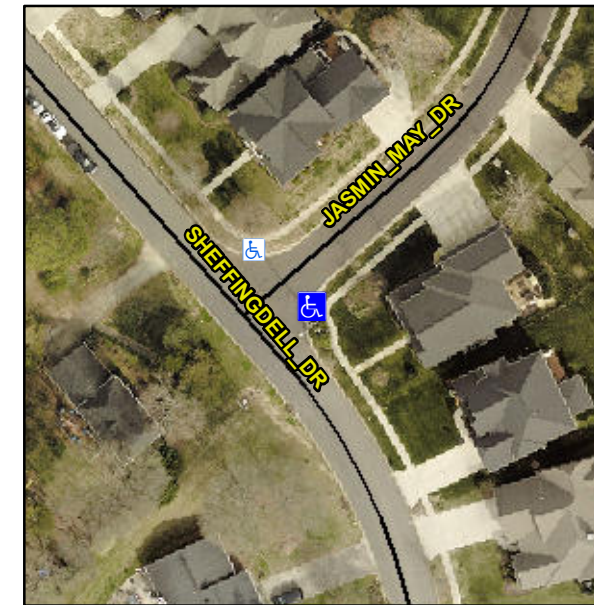
| ADA ID: A0BC27D9FCC8 | Ramp Type: PerpDiag | Initial Pass/Fail: Fail | Overall Compliance: No |

Not Found, R304.5.1

| Compliance | Description | Data | Compliance | Description | Data |
|---|---|---|---|---|---|
| N/A | Ramp Length (in) | 49.0 | Yes | Ramp Slope (%) | 7.0 |
| No | Ramp Width (in) | 47.0 | Yes | Ramp XSlope (%) | 0.7 |

Remove & Replace Curb Ramp With Two New Directional Ramps or Equivalent.

Total Cost: \$ 3200.00
