# Access Compliance Report

## Public Rights-of-Way

### (Curb Ramps)

Intersection ID: 10141	Main Street: MILL_RD	Cross Street: W_TRADE_ST	Location: S
ADA ID: A0BFC9246183	Ramp Type: Perp	Initial Pass/Fail: Fail	Overall Compliance: No
		Severity Score: 12.5

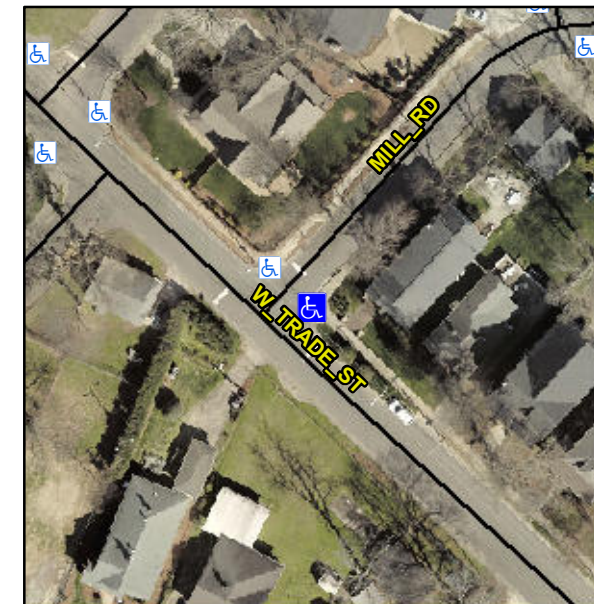
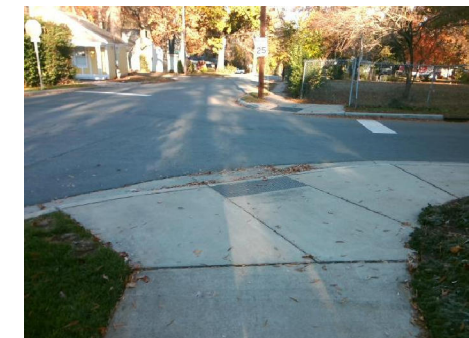
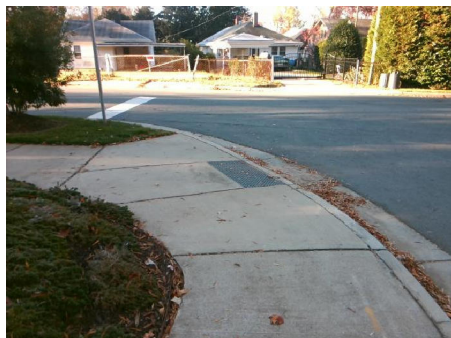
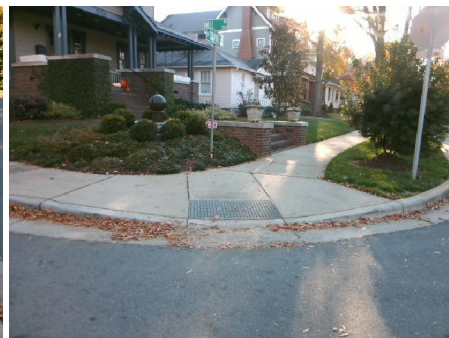
**Not Found, R304.2.2**

Compliance	Description	Data	Compliance	Description	Data
N/A	Ramp Length (in)	48.0	No	Ramp Slope (%)	10.7
Yes	Ramp Width (in)	48.0	Yes	Ramp XSlope (%)	0.7
N/A	Flare Type LT	N/A	N/A	Flare Type RT	N/A
N/A	Flare Slope LT (%)	N/A	N/A	Flare Slope RT (%)	N/A
N/A	Flare Traversable LT?	N/A	N/A	Flare Traversable RT?	N/A
N/A	Landing Length (in)	N/A	N/A	DWS Provided?	N/A
N/A	Landing Width (in)	N/A	N/A	DWS Contrast?	N/A
N/A	Landing Slope (%)	N/A	N/A	DWS Length (in)	N/A
N/A	Landing X Slope (%)	N/A	N/A	DWS Full Width?	N/A
N/A	Landing Curb? (Y/N)	N/A	N/A	DWS Offset (in)	N/A
N/A	Shared Landing?	N/A			
N/A	Gutter Ponding?	N/A	N/A	Gutter Slope (%)	N/A
N/A	Gutter Lip Ht (in)	N/A	N/A	Gutter X Slope (%)	N/A
N/A	Painted X Walk1?	No	N/A	Painted X Walk2?	N/A
	X Walk 1 Direction	To NW		X Walk 2 Direction	N/A
N/A	X Walk 1 Width (in)	N/A	N/A	X Walk 2 Width (in)	N/A
	X Walk 1 Slope (%)	1.1		X Walk 2 Slope (%)	N/A
	X Walk 1 X Slope (%)	1.4		X Walk 2 X Slope (%)	N/A

N/A	Ramp inside XWalk1?	N/A	N/A	Ramp inside XWalk2?	N/A
	Road Slope (%)	N/A	N/A	Clear Space?	N/A
	Road X Slope (%)	N/A	N/A	Clear Space to XWalk (in)	N/A
N/A	Any Obstructions?	N/A	N/A	Storm Grate/Utility Hazard?	N/A
	Obstruction Type			Storm Grate/Utility Type	
		N/A			N/A
			Yes	Surface Condition? (G/P)	Good

**Remove & Replace Entire Ramp.**

Total Cost: \$ 1850.00
