# Access Compliance Report

## Public Rights-of-Way

### (Curb Ramps)

Intersection ID: N/A	Main Street: NATIONS_FORD_RD	Cross Street: IVERIFY	Location: SE
ADA ID: A0CB6A34D54E	Ramp Type: ParaDiag	Initial Pass/Fail: Fail	Overall Compliance: No
		Severity Score: 25

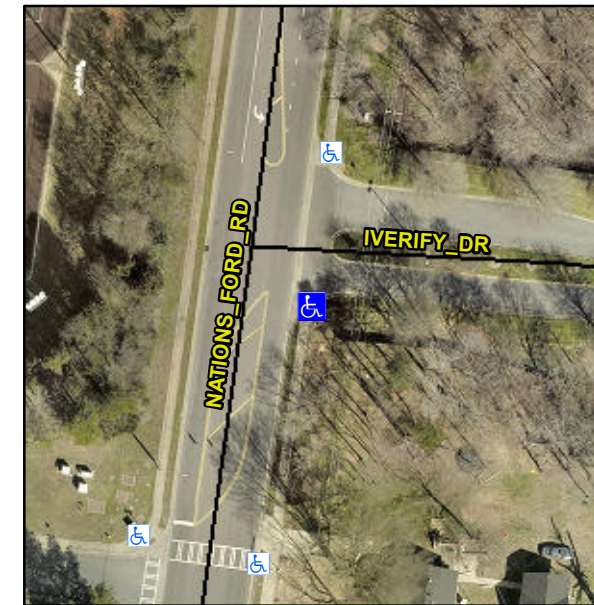
**LT RP < 5%**

**R304.3.2**

Compliance	Description	Data	Compliance	Description	Data
N/A	Ramp Length LT (in)	48.0	N/A	Ramp Length RT (in)	55.0
Yes	Ramp Width LT (in)	67.0	Yes	Ramp Width RT (in)	74.0
Yes	Ramp Slope LT (%)	0.2	No	Ramp Slope RT (%)	13.7
Yes	Ramp XSlope LT (%)	1.4	Yes	Ramp XSlope RT (%)	1.5
N/A	Landing Length (in)	N/A	N/A	DWS Provided?	N/A
N/A	Landing Width (in)	N/A	N/A	DWS Contrast?	N/A
N/A	Landing Slope (%)	N/A	N/A	DWS Length (in)	N/A
N/A	Landing X Slope (%)	N/A	N/A	DWS Full Width?	N/A
N/A	Landing Curb? (Y/N)	N/A	N/A	DWS Offset (in)	N/A
N/A	Shared Landing?	N/A			
N/A	Gutter Ponding?	N/A	N/A	Gutter Slope (%)	N/A
N/A	Gutter Lip Ht (in)	N/A	N/A	Gutter X Slope (%)	N/A
N/A	Painted X Walk1?	No	N/A	Painted X Walk2?	No
	X Walk 1 Direction	To N		X Walk 2 Direction	To W
N/A	X Walk 1 Width (in)	N/A	N/A	X Walk 2 Width (in)	N/A
	X Walk 1 Slope (%)	0.0		X Walk 2 Slope (%)	3.5
	X Walk 1 X Slope (%)	3.4		X Walk 2 X Slope (%)	3.6
N/A	Ramp inside XWalk1?	N/A	N/A	Ramp inside XWalk2?	N/A

**Remove & Replace Curb Ramp With Two New Directional Ramps or Equivalent.**

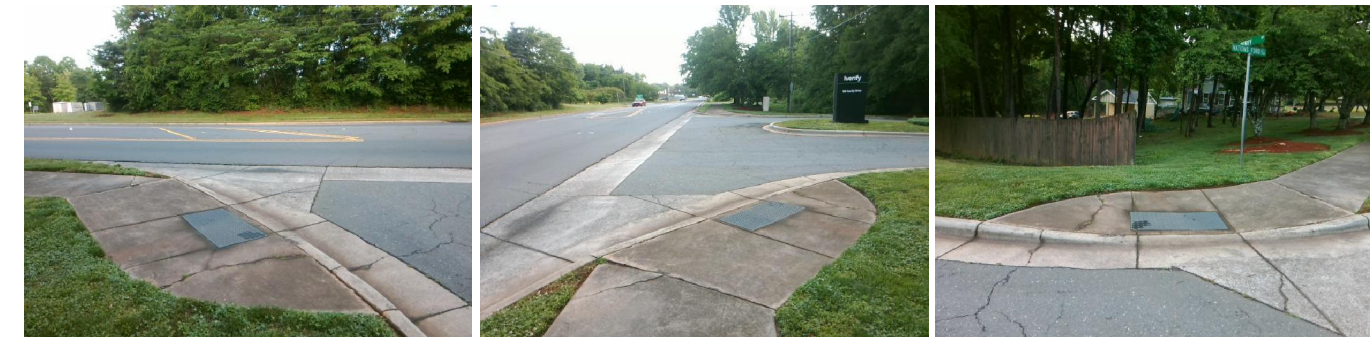
Road Slope (%)	3.3	N/A	Clear Space?	N/A
	Road X Slope (%)	3.9	N/A	Clear Space to XWalk (in)	N/A
N/A	Any Obstructions?	N/A	N/A	Storm Grate/Utility Hazard?	N/A
	Obstruction Type			Storm Grate/Utility Type	
		N/A			N/A
			Yes	Surface Condition? (G/P)	Good
			N/A	Curb Slope (%)	5.1
