Access Compliance Report

Public Rights-of-Way

(Curb Ramps)

Intersection ID: 10263	Main Street: BRICE_ST	Cross Street: PARKWAY_AV	Location: N
ADA ID: A0E55E577D4E	Ramp Type: Perp	Initial Pass/Fail: Fail	Overall Compliance: No
Severity Score: 13.75			
Codes/Mitigation Info/Possible Solution		Field Measurements/Component Compliance

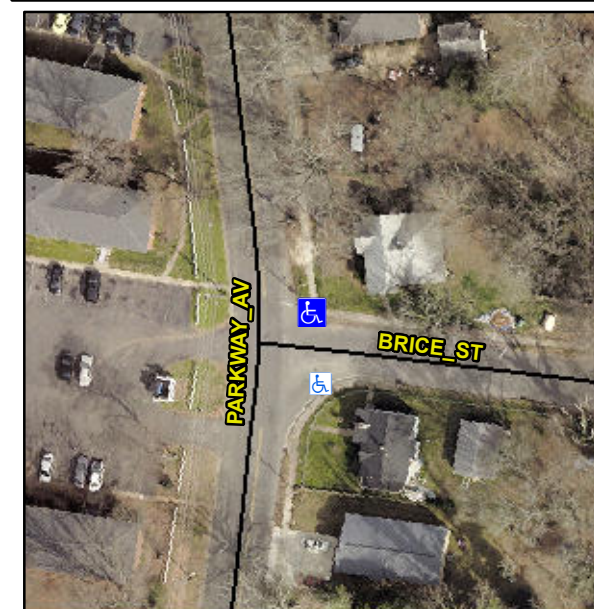
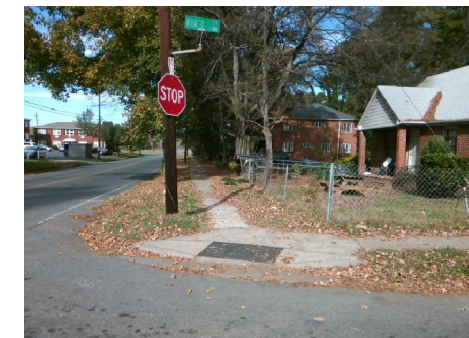
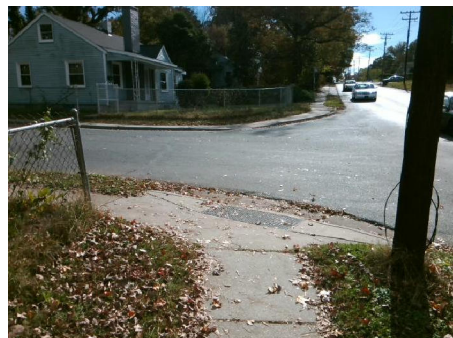
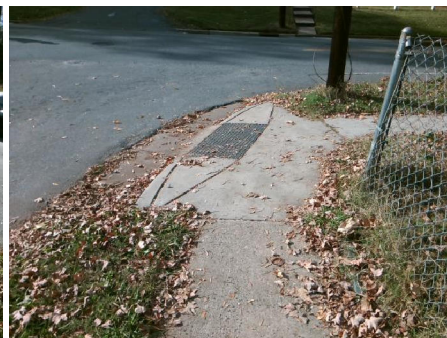
Not Found, R304.2.2, R304.5.3

Compliance	Description	Data	Compliance	Description	Data
N/A	Ramp Length (in)	26.0	No	Ramp Slope (%)	8.4
Yes	Ramp Width (in)	48.0	No	Ramp XSlope (%)	3.1
N/A	Flare Type LT	N/A	N/A	Flare Type RT	N/A
N/A	Flare Slope LT (%)	N/A	N/A	Flare Slope RT (%)	N/A
N/A	Flare Traversable LT?	N/A	N/A	Flare Traversable RT?	N/A
N/A	Landing Length (in)	N/A	N/A	DWS Provided?	N/A
N/A	Landing Width (in)	N/A	N/A	DWS Contrast?	N/A
N/A	Landing Slope (%)	N/A	N/A	DWS Length (in)	N/A
N/A	Landing X Slope (%)	N/A	N/A	DWS Full Width?	N/A
N/A	Landing Curb? (Y/N)	N/A	N/A	DWS Offset (in)	N/A
N/A	Shared Landing?	N/A			
N/A	Gutter Ponding?	N/A	N/A	Gutter Slope (%)	N/A
N/A	Gutter Lip Ht (in)	1.5	N/A	Gutter X Slope (%)	N/A
N/A	Painted X Walk1?	No	N/A	Painted X Walk2?	N/A
	X Walk 1 Direction	To S		X Walk 2 Direction	N/A
N/A	X Walk 1 Width (in)	N/A	N/A	X Walk 2 Width (in)	N/A
	X Walk 1 Slope (%)	4.9		X Walk 2 Slope (%)	N/A
	X Walk 1 X Slope (%)	2.6		X Walk 2 X Slope (%)	N/A

N/A	Ramp inside XWalk1?	N/A	N/A	Ramp inside XWalk2?	N/A
	Road Slope (%)	N/A	N/A	Clear Space?	N/A
	Road X Slope (%)	N/A	N/A	Clear Space to XWalk (in)	N/A
N/A	Any Obstructions?	N/A	N/A	Storm Grate/Utility Hazard?	N/A
	Obstruction Type			Storm Grate/Utility Type	
		N/A			N/A
			Yes	Surface Condition? (G/P)	Good

Possible Solutions:

Remove & Replace Entire Ramp.
