Access Compliance Report

Public Rights-of-Way

(Curb Ramps)

Intersection ID: 10745	Main Street: E_35TH_ST	Cross Street: HOLT_ST	Location: S
ADA ID: A0EC7B0DF595	Ramp Type: Perp	Initial Pass/Fail: Pass	Overall Compliance: No
Codes/Mitigation Info/Possible Solution		Field Measurements/Component Compliance	
Severity Score: 15

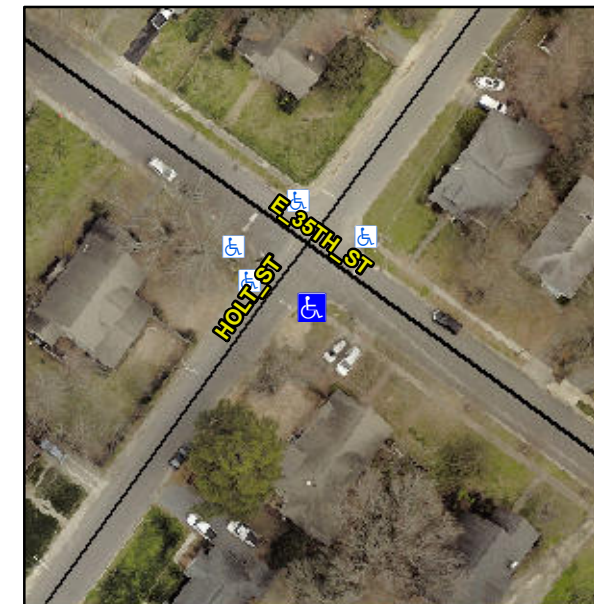
**Not Found, R304.2.1, R304.2.2-Perp,
R304.3.2-Para, R304.5.3, R304.5.4**

Compliance	Description	Data	Compliance	Description	Data
N/A	Ramp Length (in)	41.5	Yes	Ramp Slope (%)	7.6
Yes	Ramp Width (in)	48.0	Yes	Ramp XSlope (%)	0.3
N/A	Flare Type LT	Sloped	N/A	Flare Type RT	N/A
N/A	Flare Slope LT (%)	9.5	N/A	Flare Slope RT (%)	9.2
N/A	Flare Traversable LT?	No	N/A	Flare Traversable RT?	No
No	Landing Length (in)	N/A	Yes	DWS Provided?	Yes
No	Landing Width (in)	N/A	Yes	DWS Contrast?	Yes
No	Landing Slope (%)	N/A	Yes	DWS Length (in)	24.0
No	Landing X Slope (%)	N/A	Yes	DWS Full Width?	Yes
N/A	Landing Curb? (Y/N)	No	Yes	DWS Offset (in)	0.0
N/A	Shared Landing?	No			
Yes	Gutter Ponding?	No	No	Gutter Slope (%)	5.7
Yes	Gutter Lip Ht (in)	0.0	Yes	Gutter X Slope (%)	1.8
N/A	Painted X Walk1?	No	N/A	Painted X Walk2?	N/A
	X Walk 1 Direction	To NW		X Walk 2 Direction	N/A
N/A	X Walk 1 Width (in)	N/A	N/A	X Walk 2 Width (in)	N/A
	X Walk 1 Slope (%)	0.6		X Walk 2 Slope (%)	N/A
	X Walk 1 X Slope (%)	1.0		X Walk 2 X Slope (%)	N/A

N/A	Ramp inside XWalk1?	N/A	N/A	Ramp inside XWalk2?	N/A
	Road Slope (%)	N/A	N/A	Clear Space?	Yes
	Road X Slope (%)	N/A	N/A	Clear Space to XWalk (in)	N/A
Yes	Any Obstructions?	No	Yes	Storm Grate/Utility Hazard?	No
	Obstruction Type			Storm Grate/Utility Type	
		N/A			N/A
			Yes	Surface Condition? (G/P)	Good

Possible Solutions:

**Remove & Replace Entire Ramp.
Remove & Replace Gutter.**
