Access Compliance Report Public Rights-of-Way (Curb Ramps)

Intersection ID: 28517 Main Street: BROOKMERE_LN Cross Street: MT_HOLLY-HUNTERSVILLE_RD Location: ADA ID: A0F361AD0AB0 Ramp Type: BlendTrans1 Initial Pass/Fail: Fail **Overall Compliance: No** Severity Score: 33.75

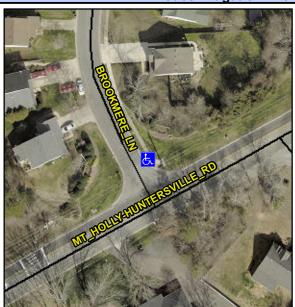
Field Measurements/Component Compliance						
	Compliance Description		Data	Compliance Description		Data
	N/A	Ramp Length (in)	43.0	Yes	BlendTrans Slope (%)	4.2
	No	Ramp Width (in)	43.0	No	BlendTrans XSlope (%)	9.3
	N/A	Flare Type LT	N/A	N/A	Flare Type RT	N/A
	N/A	Flare Slope LT (%)	N/A	N/A	Flare Slope RT (%)	N/A
	N/A	Flare Traversable LT?	N/A	N/A	Flare Traversable RT?	N/A
	N/A	Landing Length (in)	N/A	N/A	DWS Provided?	N/A
	N/A	Landing Width (in)	N/A	N/A	DWS Contrast?	N/A
	N/A	Landing Slope (%)	N/A	N/A	DWS Length (in)	N/A
	N/A	Landing X Slope (%)	N/A	N/A	DWS Full Width?	N/A
	N/A	Landing Curb? (Y/N)	N/A	N/A	DWS Offset (in)	N/A
	N/A	Shared Landing?	N/A			
	N/A	Gutter Ponding?	N/A	N/A	Gutter Slope (%)	N/A
	N/A	Gutter Lip Ht (in)	N/A	N/A	Gutter X Slope (%)	N/A
	N/A	Painted X Walk1?	No	N/A	Painted X Walk2?	N/A
		X Walk 1 Direction	To W		X Walk 2 Direction	N/A
		X Walk 1 Width (in)	N/A		X Walk 2 Width (in)	N/A
		X Walk 1 Slope (%)	3.4		X Walk 2 Slope (%)	N/A

X Walk 1 X Slope (%)	6.0		X Walk 2 X Slope (%)	N/A
	N/A	Ramp inside XWalk1?	N/A	N/A	Ramp inside XWalk2?	N/A
		Road Slope (%)	6.0		Clear Space?	N/A
		Road X Slope (%)	3.4	N/A	Clear Space to XWalk (in)	N/A
	N/A	Any Obstructions?	N/A	N/A	Storm Grate/Utility Hazard?	N/A
		Obstruction Type			Storm Grate/Utility Type	
			N/A			N/A
				Yes	Surface Condition? (G/P)	Good
				No	Curb Slope (%)	17.2
	THE PERSON NAMED IN

Possible Solutions: Remove & Replace Curb Ramp With Two New Directional Ramps or Equivalent. Surveyor Notes: N/A PROW/ADA: Not Found, R304.5.1, R304.5.3
