# Access Compliance Report

## Public Rights-of-Way

### (Curb Ramps)

| Intersection ID: 47810 | Main Street: NEVIN_GLEN_DR | Cross Street: GRAYPARK_DR | Location: SE |

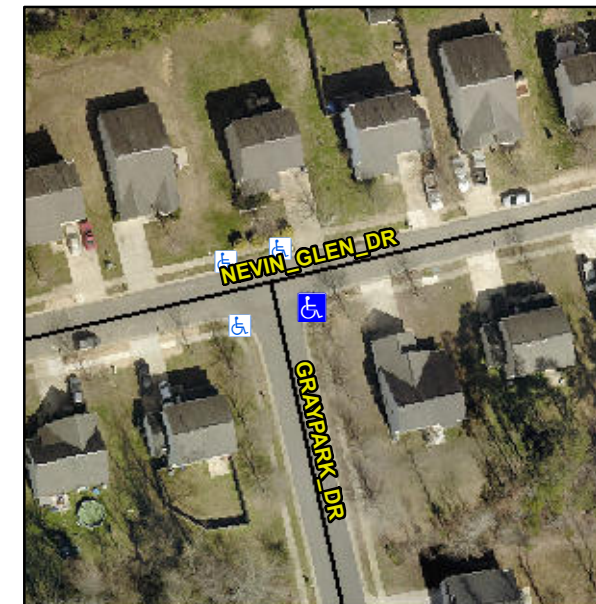
| ADA ID: A0F637DADFBA | Ramp Type: PerpDiag | Initial Pass/Fail: Fail | Overall Compliance: No |
| Severity Score: 36.25 | | | |

**Not Found, R304.5.1, R304.5.3, R302.7**

| Compliance | Description | Data | Compliance | Description | Data |
|---|---|---|---|---|---|
| N/A | Ramp Length (in) | 49.0 | Yes | Ramp Slope (%) | 6.2 |
| No | Ramp Width (in) | 36.5 | No | Ramp XSlope (%) | 5.7 |
| | | No | | Surface Condition? (G/P) | Poor |

**Remove & Replace Curb Ramp With Two New Directional Ramps or Equivalent.**

Total Cost: \$ 3200.00
