Access Compliance Report Public Rights-of-Way (Curb Ramps)

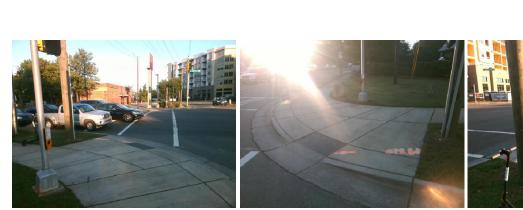
Intersection ID: 15402	Cross Street: NEW DEDN ST				Location:	SW		
	Main Street: MARSH_RD			Cross Street: NEW_BERN_ST				
ADA ID: A0F6C349DCA5 Ramp Type: Perp		Initial Pass/Fail: Fail Overall Compliance: No			o Severity Score:	12.5		
Codes/Mitigation Info/Possible Solution			Field Measurements/Component Compliance					
	11/2	Possible Solutions:	Compliance Description Data			Compliance Description		Data
		Remove & Replace Entire Ramp.	N/A	Ramp Length (in)	25.0	No	Ramp Slope (%)	8.4
Man	11 1		Yes	Ramp Width (in)	48.0	Yes	Ramp XSlope (%)	0.4
E CA	150, " 1		N/A	Flare Type LT	N/A	N/A	Flare Type RT	N/A
ST 1			N/A	Flare Slope LT (%)	N/A	N/A	Flare Slope RT (%)	N/A

E.	1 MARE X	1	N/A	Shared Landing?	N/A			
	11/17/20	PROW/ADA:	N/A	Gutter Ponding?	N/A	N/A	Gutter Slope (%)	N/A
Y AND		Not Found, R304.2.2	N/A	Gutter Lip Ht (in)	N/A	N/A	Gutter X Slope (%)	N/A
	5 m 1	,	N/A	Painted X Walk1?	Yes	N/A	Painted X Walk2?	N/A
				X Walk 1 Direction	To NW		X Walk 2 Direction	N/A
1 Bastra MA			N/A	X Walk 1 Width (in)	109.0	N/A	X Walk 2 Width (in)	N/A
Street 1 Name	SOUTH BV			X Walk 1 Slope (%)	3.4		X Walk 2 Slope (%)	N/A
Stop Condition-Street 2	Signal			X Walk 1 X Slope (%)	2.0		X Walk 2 X Slope (%)	N/A
Street 2 Name	N/A		N/A	Ramp inside XWalk1?	Yes	N/A	Ramp inside XWalk2?	N/A
Stop Condition-Street 1	N/A			Road Slope (%)	N/A	N/A	Clear Space?	N/A
				Road X Slope (%)	N/A	N/A	Clear Space to XWalk (in)	N/A
			N/A	Any Obstructions?	N/A	N/A	Storm Grate/Utility Hazard?	N/A
		Total Cost: \$ 1	850.00	Obstruction Type			Storm Grate/Utility Type	
					N/A			N/A
