# Access Compliance Report

## Public Rights-of-Way

### (Curb Ramps)

Intersection ID: 24374	Main Street: BEVERLY_CREST_BV	Cross Street: HUGH_FOREST_RD	Location: W
ADA ID: A0FD84D55C6D	Ramp Type: Perp	Initial Pass/Fail: Fail	Overall Compliance: No
Severity Score: 25			
Codes/Mitigation Info/Possible Solution		Field Measurements/Component Compliance

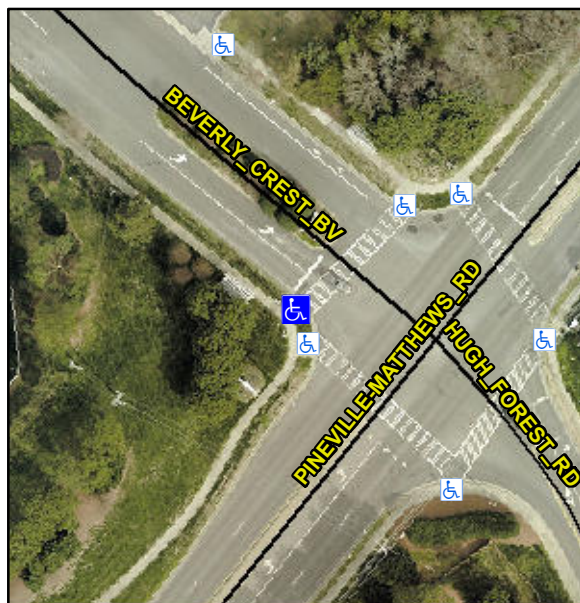
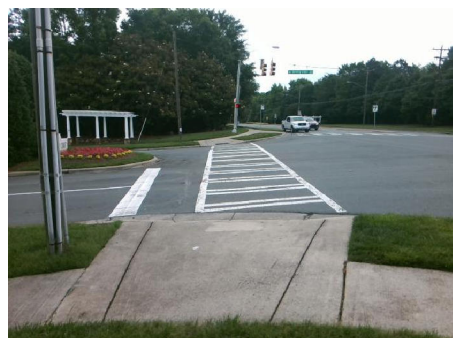
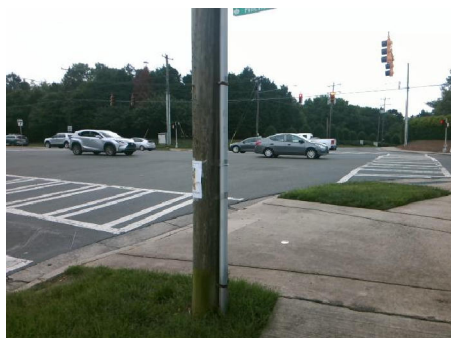
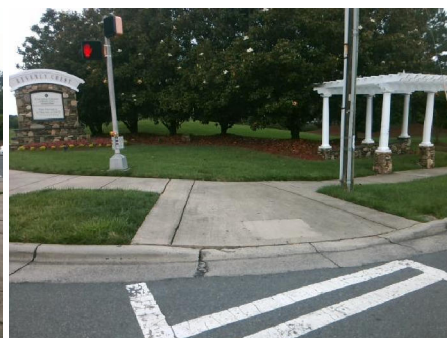
**Not Found, R304.5.3**

Compliance	Description	Data	Compliance	Description	Data
N/A	Ramp Length (in)	94.0	Yes	Ramp Slope (%)	8.1
Yes	Ramp Width (in)	72.0	No	Ramp XSlope (%)	7.6
N/A	Flare Type LT	N/A	N/A	Flare Type RT	N/A
N/A	Flare Slope LT (%)	N/A	N/A	Flare Slope RT (%)	N/A
N/A	Flare Traversable LT?	N/A	N/A	Flare Traversable RT?	N/A
N/A	Landing Length (in)	N/A	N/A	DWS Provided?	N/A
N/A	Landing Width (in)	N/A	N/A	DWS Contrast?	N/A
N/A	Landing Slope (%)	N/A	N/A	DWS Length (in)	N/A
N/A	Landing X Slope (%)	N/A	N/A	DWS Full Width?	N/A
N/A	Landing Curb? (Y/N)	N/A	N/A	DWS Offset (in)	N/A
N/A	Shared Landing?	N/A			
N/A	Gutter Ponding?	N/A	N/A	Gutter Slope (%)	N/A
N/A	Gutter Lip Ht (in)	N/A	N/A	Gutter X Slope (%)	N/A
N/A	Painted X Walk1?	Yes	N/A	Painted X Walk2?	N/A
	X Walk 1 Direction	To NE		X Walk 2 Direction	N/A
N/A	X Walk 1 Width (in)	112.0	N/A	X Walk 2 Width (in)	N/A
	X Walk 1 Slope (%)	1.2		X Walk 2 Slope (%)	N/A
	X Walk 1 X Slope (%)	6.1		X Walk 2 X Slope (%)	N/A

N/A	Ramp inside XWalk1?	Yes	N/A	Ramp inside XWalk2?	N/A
	Road Slope (%)	N/A	N/A	Clear Space?	N/A
	Road X Slope (%)	N/A	N/A	Clear Space to XWalk (in)	N/A
N/A	Any Obstructions?	N/A	N/A	Storm Grate/Utility Hazard?	N/A
	Obstruction Type			Storm Grate/Utility Type	
		N/A			N/A
		Yes		Surface Condition? (G/P)	Good

**Remove & Replace Entire Ramp.**
