Access Compliance Report

Public Rights-of-Way

(Curb Ramps)

Intersection ID: 9396	Main Street: MORETZ_AV	Cross Street: N_GRAHAM_ST	Location: S
ADA ID: A10AC90066E1	Ramp Type: PerpDiag	Initial Pass/Fail: Fail	Overall Compliance: No
		Severity Score: 25

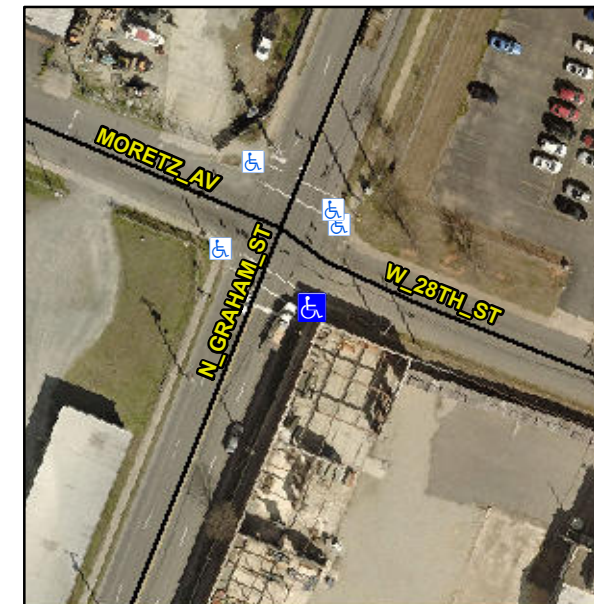
Not Found, R304.2.2

Compliance	Description	Data	Compliance	Description	Data
N/A	Ramp Length (in)	60.5	No	Ramp Slope (%)	13.5
Yes	Ramp Width (in)	48.0	Yes	Ramp XSlope (%)	0.6
N/A	Flare Type LT	N/A	N/A	Flare Type RT	N/A
N/A	Flare Slope LT (%)	N/A	N/A	Flare Slope RT (%)	N/A
N/A	Flare Traversable LT?	N/A	N/A	Flare Traversable RT?	N/A
N/A	Landing Length (in)	N/A	N/A	DWS Provided?	N/A
N/A	Landing Width (in)	N/A	N/A	DWS Contrast?	N/A
N/A	Landing Slope (%)	N/A	N/A	DWS Length (in)	N/A
N/A	Landing X Slope (%)	N/A	N/A	DWS Full Width?	N/A
N/A	Landing Curb? (Y/N)	N/A	N/A	DWS Offset (in)	N/A
N/A	Shared Landing?	N/A			
N/A	Gutter Ponding?	N/A	N/A	Gutter Slope (%)	N/A
N/A	Gutter Lip Ht (in)	N/A	N/A	Gutter X Slope (%)	N/A
N/A	Painted X Walk1?	No	N/A	Painted X Walk2?	Yes
	X Walk 1 Direction	To NE		X Walk 2 Direction	To NW
N/A	X Walk 1 Width (in)	N/A	N/A	X Walk 2 Width (in)	99.0
	X Walk 1 Slope (%)	2.4		X Walk 2 Slope (%)	2.8
	X Walk 1 X Slope (%)	3.9		X Walk 2 X Slope (%)	0.2

N/A	Ramp inside XWalk1?	N/A	N/A	Ramp inside XWalk2?	Yes
	Road Slope (%)	0.2	N/A	Clear Space?	N/A
	Road X Slope (%)	2.4	N/A	Clear Space to XWalk (in)	N/A
N/A	Any Obstructions?	N/A	N/A	Storm Grate/Utility Hazard?	N/A
	Obstruction Type			Storm Grate/Utility Type	
		N/A			N/A
			Yes	Surface Condition? (G/P)	Good

Remove & Replace Curb Ramp With Two New Directional Ramps or Equivalent.

Total Cost: \$ 3200.00
