Access Compliance Report

Public Rights-of-Way

(Curb Ramps)

| Intersection ID: 46491 | Main Street: BERE_ISLAND_DR | Cross Street: CASTLECOVE_RD | Location: SE |

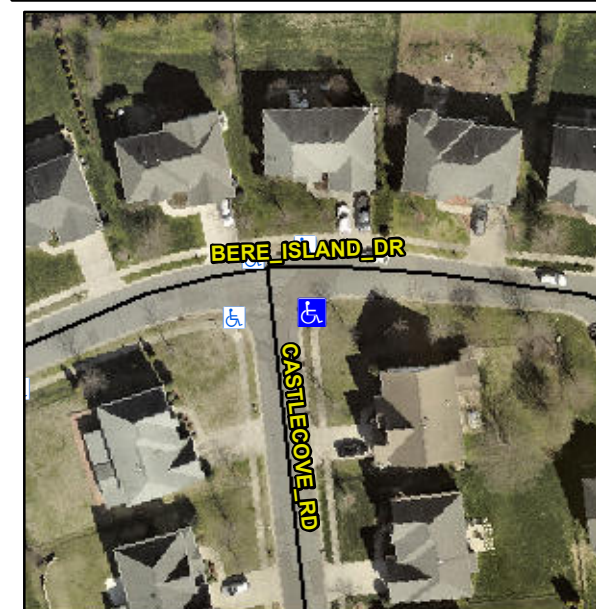
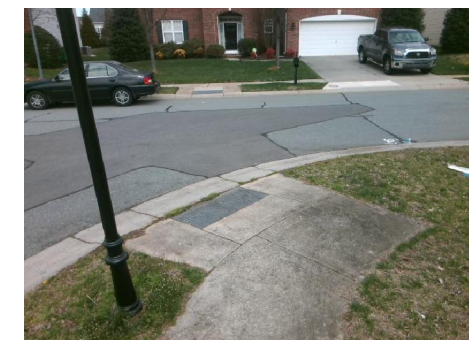
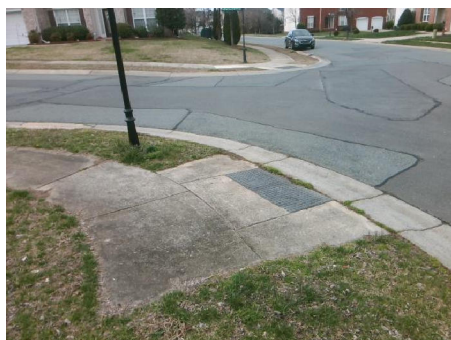
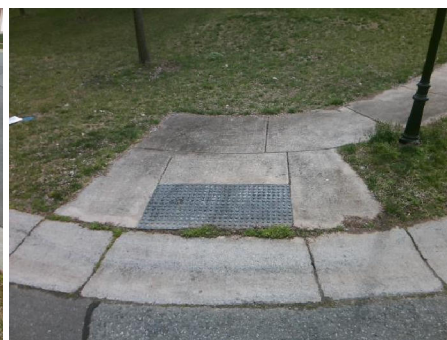
| ADA ID: A10C18A9C141 | Ramp Type: PerpDiag | Initial Pass/Fail: Fail | Overall Compliance: No |
| Severity Score: 22.5 | | | |

Not Found, R304.5.1, R304.2.2, R304.5.3

| Compliance | Description | Data | Compliance | Description | Data |
|---|---|---|---|---|---|
| N/A | Ramp Length (in) | 48.0 | No | Ramp Slope (%) | 11.4 |
| No | Ramp Width (in) | 46.5 | No | Ramp XSlope (%) | 2.2 |

Remove & Replace Curb Ramp With Two New Directional Ramps or Equivalent.
