Access Compliance Report

Public Rights-of-Way

(Curb Ramps)

Intersection ID: 44936	Main Street: REEDMONT_LN	Cross Street: ACORN_FOREST_LN	Location: E
ADA ID: A10F34EAE5C3	Ramp Type: Perp	Initial Pass/Fail: Fail	Overall Compliance: No
Severity Score: 22.5			
Codes/Mitigation Info/Possible Solution		Field Measurements/Component Compliance

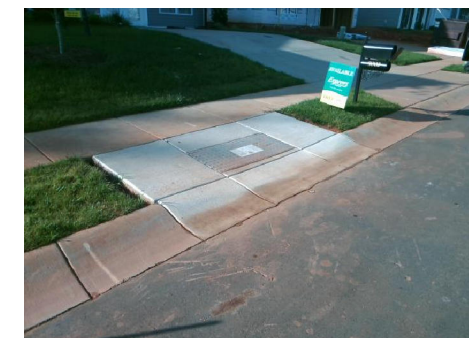
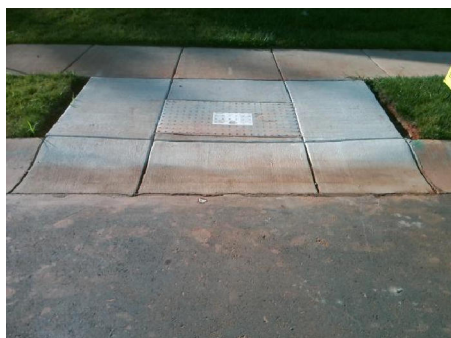
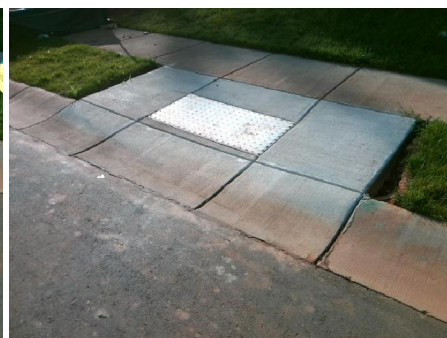
Not Found, R304.5.1, R304.2.2

Compliance	Description	Data	Compliance	Description	Data
N/A	Ramp Length (in)	47.5	No	Ramp Slope (%)	8.7
No	Ramp Width (in)	46.5	Yes	Ramp XSlope (%)	2.5
N/A	Flare Type LT	N/A	N/A	Flare Type RT	N/A
N/A	Flare Slope LT (%)	N/A	N/A	Flare Slope RT (%)	N/A
N/A	Flare Traversable LT?	N/A	N/A	Flare Traversable RT?	N/A
N/A	Landing Length (in)	N/A	N/A	DWS Provided?	N/A
N/A	Landing Width (in)	N/A	N/A	DWS Contrast?	N/A
N/A	Landing Slope (%)	N/A	N/A	DWS Length (in)	N/A
N/A	Landing X Slope (%)	N/A	N/A	DWS Full Width?	N/A
N/A	Landing Curb? (Y/N)	N/A	N/A	DWS Offset (in)	N/A
N/A	Shared Landing?	N/A			
N/A	Gutter Ponding?	N/A	N/A	Gutter Slope (%)	N/A
N/A	Gutter Lip Ht (in)	N/A	N/A	Gutter X Slope (%)	N/A
N/A	Painted X Walk1?	No	N/A	Painted X Walk2?	N/A
	X Walk 1 Direction	To NW		X Walk 2 Direction	N/A
N/A	X Walk 1 Width (in)	N/A	N/A	X Walk 2 Width (in)	N/A
	X Walk 1 Slope (%)	3.1		X Walk 2 Slope (%)	N/A
	X Walk 1 X Slope (%)	2.7		X Walk 2 X Slope (%)	N/A

N/A	Ramp inside XWalk1?	N/A	N/A	Ramp inside XWalk2?	N/A
	Road Slope (%)	N/A	N/A	Clear Space?	N/A
	Road X Slope (%)	N/A	N/A	Clear Space to XWalk (in)	N/A
N/A	Any Obstructions?	N/A	N/A	Storm Grate/Utility Hazard?	N/A
	Obstruction Type			Storm Grate/Utility Type	
		N/A			N/A
			Yes	Surface Condition? (G/P)	Good

Possible Solutions:

Remove & Replace Entire Ramp.
