# Access Compliance Report

## Public Rights-of-Way

### (Curb Ramps)

Intersection ID: 49818	Main Street: LEES_CROSSING_DR	Cross Street: ASHLEY_VIEW_DR	Location: NE
ADA ID: A115A61EB794	Ramp Type: PerpDiag	Initial Pass/Fail: Fail	Overall Compliance: No
Severity Score: 22.5			
Codes/Mitigation Info/Possible Solution		Field Measurements/Component Compliance

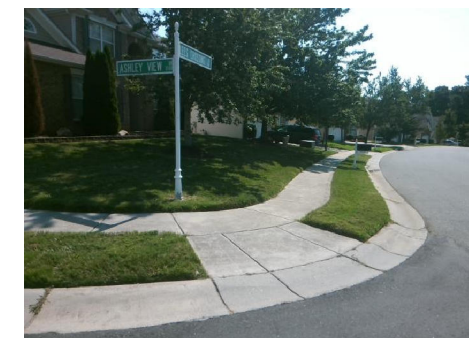
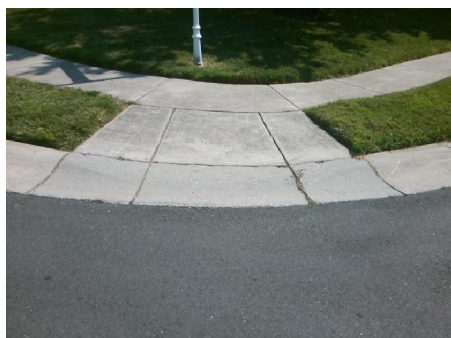
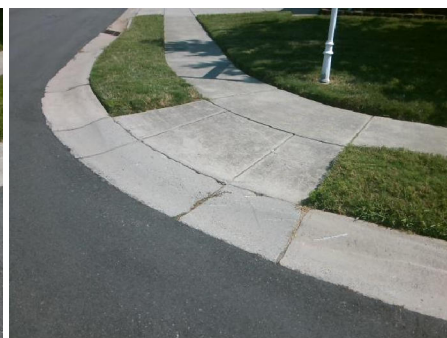
**Not Found, R304.5.1, R304.2.2, R304.5.3**

Compliance	Description	Data	Compliance	Description	Data
N/A	Ramp Length (in)	47.0	No	Ramp Slope (%)	9.9
No	Ramp Width (in)	37.5	No	Ramp XSlope (%)	4.6
N/A	Flare Type LT	N/A	N/A	Flare Type RT	N/A
N/A	Flare Slope LT (%)	N/A	N/A	Flare Slope RT (%)	N/A
N/A	Flare Traversable LT?	N/A	N/A	Flare Traversable RT?	N/A
N/A	Landing Length (in)	N/A	N/A	DWS Provided?	N/A
N/A	Landing Width (in)	N/A	N/A	DWS Contrast?	N/A
N/A	Landing Slope (%)	N/A	N/A	DWS Length (in)	N/A
N/A	Landing X Slope (%)	N/A	N/A	DWS Full Width?	N/A
N/A	Landing Curb? (Y/N)	N/A	N/A	DWS Offset (in)	N/A
N/A	Shared Landing?	N/A			
N/A	Gutter Ponding?	N/A	N/A	Gutter Slope (%)	N/A
N/A	Gutter Lip Ht (in)	N/A	N/A	Gutter X Slope (%)	N/A
N/A	Painted X Walk1?	No	N/A	Painted X Walk2?	No
	X Walk 1 Direction	To W		X Walk 2 Direction	To S
N/A	X Walk 1 Width (in)	N/A	N/A	X Walk 2 Width (in)	N/A
	X Walk 1 Slope (%)	3.9		X Walk 2 Slope (%)	0.5
	X Walk 1 X Slope (%)	1.7		X Walk 2 X Slope (%)	4.1

N/A	Ramp inside XWalk1?	N/A	N/A	Ramp inside XWalk2?	N/A
	Road Slope (%)	3.8	N/A	Clear Space?	N/A
	Road X Slope (%)	2.1	N/A	Clear Space to XWalk (in)	N/A
N/A	Any Obstructions?	N/A	N/A	Storm Grate/Utility Hazard?	N/A
	Obstruction Type			Storm Grate/Utility Type	
		N/A			N/A
			Yes	Surface Condition? (G/P)	Good

Possible Solutions:

**Remove & Replace Curb Ramp With Two New Directional Ramps or Equivalent.**
