# Access Compliance Report

## Public Rights-of-Way

### (Curb Ramps)

Intersection ID: 24259	Main Street: HENSEY'S_WY	Cross Street: MIROW_PL	Location: W
ADA ID: A1188D32CC14	Ramp Type: PerpDiag	Initial Pass/Fail: Fail	Overall Compliance: No
Severity Score: 21.25			
Codes/Mitigation Info/Possible Solution		Field Measurements/Component Compliance

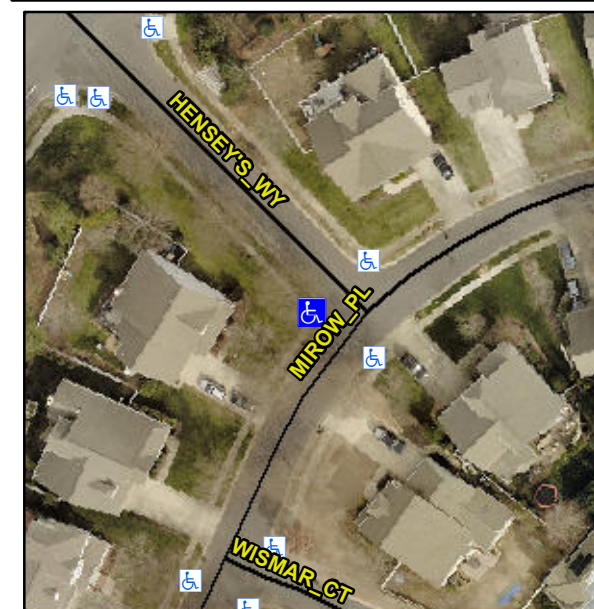
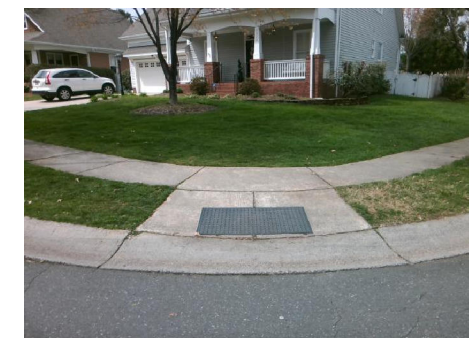
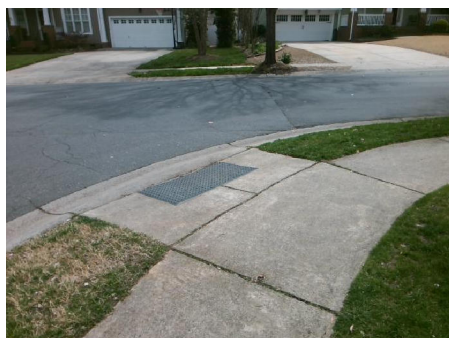
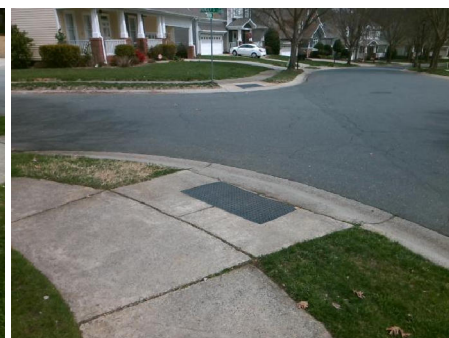
**Not Found, R304.5.1, R304.2.2**

Compliance	Description	Data	Compliance	Description	Data
N/A	Ramp Length (in)	47.0	No	Ramp Slope (%)	11.1
No	Ramp Width (in)	42.0	Yes	Ramp XSlope (%)	0.7
N/A	Flare Type LT	N/A	N/A	Flare Type RT	N/A
N/A	Flare Slope LT (%)	N/A	N/A	Flare Slope RT (%)	N/A
N/A	Flare Traversable LT?	N/A	N/A	Flare Traversable RT?	N/A
N/A	Landing Length (in)	N/A	N/A	DWS Provided?	N/A
N/A	Landing Width (in)	N/A	N/A	DWS Contrast?	N/A
N/A	Landing Slope (%)	N/A	N/A	DWS Length (in)	N/A
N/A	Landing X Slope (%)	N/A	N/A	DWS Full Width?	N/A
N/A	Landing Curb? (Y/N)	N/A	N/A	DWS Offset (in)	N/A
N/A	Shared Landing?	N/A			
N/A	Gutter Ponding?	N/A	N/A	Gutter Slope (%)	N/A
N/A	Gutter Lip Ht (in)	N/A	N/A	Gutter X Slope (%)	N/A
N/A	Painted X Walk1?	No	N/A	Painted X Walk2?	No
	X Walk 1 Direction	To NE		X Walk 2 Direction	To SE
N/A	X Walk 1 Width (in)	N/A	N/A	X Walk 2 Width (in)	N/A
	X Walk 1 Slope (%)	3.0		X Walk 2 Slope (%)	1.3
	X Walk 1 X Slope (%)	0.9		X Walk 2 X Slope (%)	2.5

N/A	Ramp inside XWalk1?	N/A	N/A	Ramp inside XWalk2?	N/A
	Road Slope (%)	1.9	N/A	Clear Space?	N/A
	Road X Slope (%)	2.1	N/A	Clear Space to XWalk (in)	N/A
N/A	Any Obstructions?	N/A	N/A	Storm Grate/Utility Hazard?	N/A
	Obstruction Type			Storm Grate/Utility Type	
		N/A			N/A
			Yes	Surface Condition? (G/P)	Good

**Remove & Replace Curb Ramp With Two New Directional Ramps or Equivalent.**
