Access Compliance Report

Public Rights-of-Way

(Curb Ramps)

| Intersection ID: 2710 | Main Street: FAIRVISTA_DR | Cross Street: QUEENSBURY_CT | Location: NW |

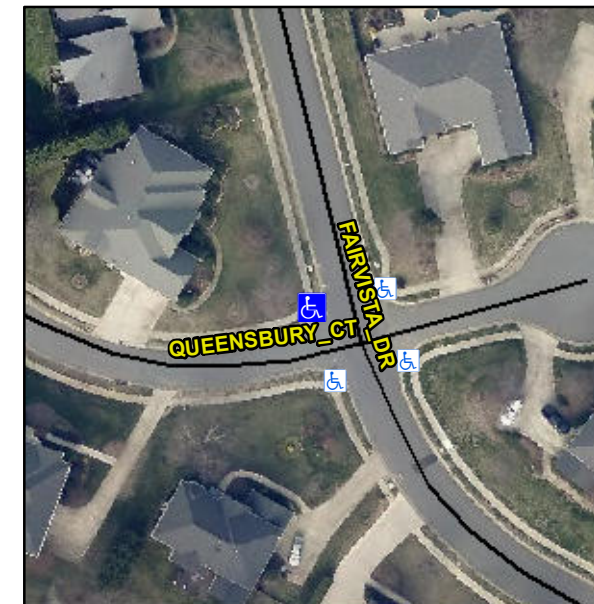
Not Found, R304.2.2-Perp, R304.3.2-Para, R305

| Compliance | Description | Data | Compliance | Description | Data |
|---|---|---|---|---|---|
| Yes | Landing Length (in) | 55.0 | No | DWS Provided? | No |
| No | Landing Slope (%) | 4.4 | N/A | DWS Length (in) | N/A |

Remove & Replace Curb Ramp With Two New Directional Ramps or Equivalent.
