# Access Compliance Report

## Public Rights-of-Way

### (Curb Ramps)

| Intersection ID: 14741 | Main Street: EAST_BV | Cross Street: PARK_RD | Location: SW |

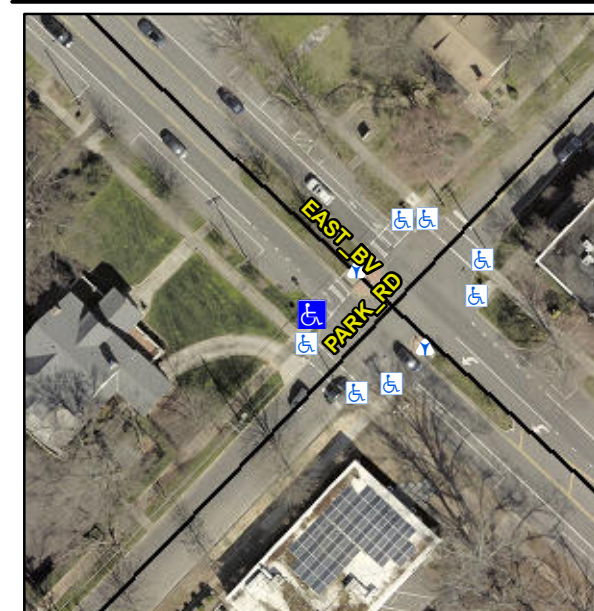
**LNDG SLOPE NEGATIVE**

**R304.5.3, R304.2.2-Perp, R304.3.2-Para, R304.5.2**

| Compliance | Description | Data | Compliance | Description | Data |
|---|---|---|---|---|---|
| No | Ramp XSlope (%) | 4.9 | | | |
| No | Landing Slope (%) | 6.4 | Yes | DWS Length (in) | 24.5 |
| No | Landing X Slope (%) | 2.9 | Yes | DWS Full Width? | Yes |

**Remove & Replace Entire Ramp.**

Total Cost: \$ 1600.00
