Access Compliance Report

Public Rights-of-Way

(Curb Ramps)

Intersection ID: 25971	Main Street: CARMEL COMMONS BV	Cross Street: EL GRECO CT	Location: SE
ADA ID: A12E3F4B2EA4	Ramp Type: PerpDiag	Initial Pass/Fail: Fail	Overall Compliance: No
Severity Score: 35			
Codes/Mitigation Info/Possible Solution		Field Measurements/Component Compliance

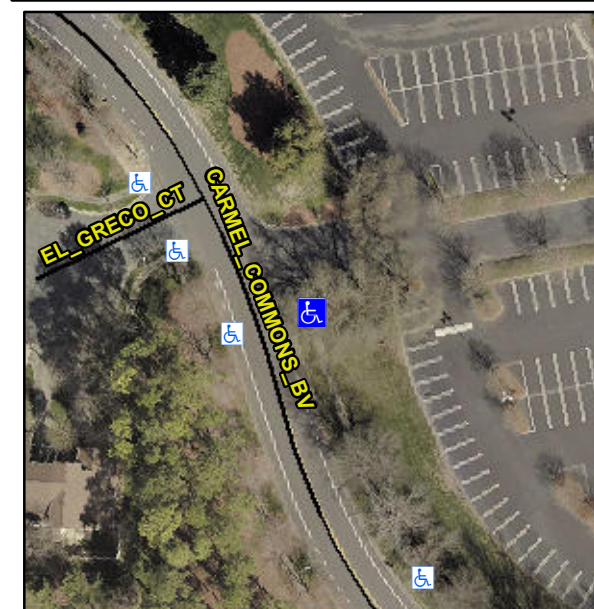
Not Found, R304.5.1, R304.2.2

Compliance	Description	Data	Compliance	Description	Data
N/A	Ramp Length (in)	42.0	No	Ramp Slope (%)	17.6
No	Ramp Width (in)	46.0	Yes	Ramp XSlope (%)	3.9
N/A	Flare Type LT	N/A	N/A	Flare Type RT	N/A
N/A	Flare Slope LT (%)	N/A	N/A	Flare Slope RT (%)	N/A
N/A	Flare Traversable LT?	N/A	N/A	Flare Traversable RT?	N/A
N/A	Landing Length (in)	N/A	N/A	DWS Provided?	N/A
N/A	Landing Width (in)	N/A	N/A	DWS Contrast?	N/A
N/A	Landing Slope (%)	N/A	N/A	DWS Length (in)	N/A
N/A	Landing X Slope (%)	N/A	N/A	DWS Full Width?	N/A
N/A	Landing Curb? (Y/N)	N/A	N/A	DWS Offset (in)	N/A
N/A	Shared Landing?	N/A			
N/A	Gutter Ponding?	N/A	N/A	Gutter Slope (%)	N/A
N/A	Gutter Lip Ht (in)	N/A	N/A	Gutter X Slope (%)	N/A
N/A	Painted X Walk1?	No	N/A	Painted X Walk2?	No
	X Walk 1 Direction	To N		X Walk 2 Direction	To W
N/A	X Walk 1 Width (in)	N/A	N/A	X Walk 2 Width (in)	N/A
	X Walk 1 Slope (%)	4.0		X Walk 2 Slope (%)	0.8
	X Walk 1 X Slope (%)	0.8		X Walk 2 X Slope (%)	4.7

N/A	Ramp inside XWalk1?	N/A	N/A	Ramp inside XWalk2?	N/A
	Road Slope (%)	4.8	N/A	Clear Space?	N/A
	Road X Slope (%)	3.7	N/A	Clear Space to XWalk (in)	N/A
N/A	Any Obstructions?	N/A	N/A	Storm Grate/Utility Hazard?	N/A
	Obstruction Type			Storm Grate/Utility Type	
		N/A			N/A
		Yes		Surface Condition? (G/P)	Good

Possible Solutions:

Remove & Replace Curb Ramp With Two New Directional Ramps or Equivalent.
