Access Compliance Report

Public Rights-of-Way (Curb Ramps)

Intersection ID: 9770	Main Street: DEMILL_LN	Cross Street: E_W_T_HARRIS_BV	Location: SE
ADA ID: A1385225F2A7	Ramp Type: PerpDiag	Initial Pass/Fail: Fail	Overall Compliance: No
Severity Score: 22.5			
Codes/Mitigation Info/Possible Solution		Field Measurements/Component Compliance

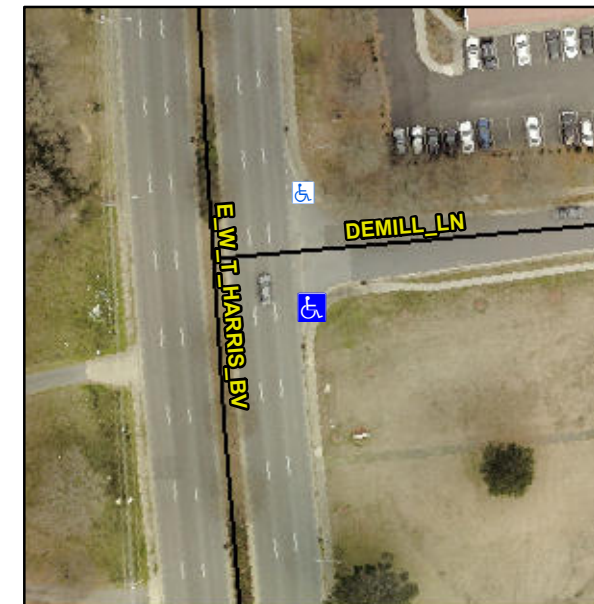
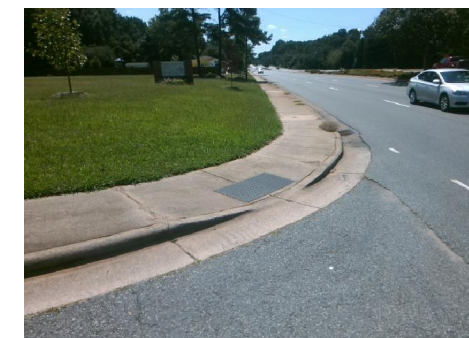
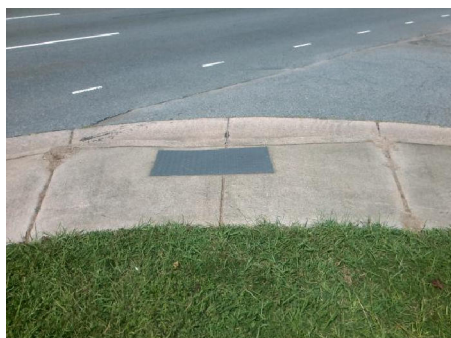
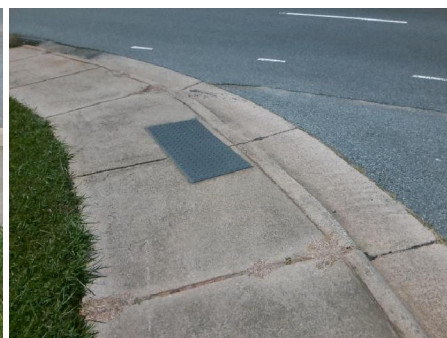
Not Found, R304.5.1, R304.2.2, R304.5.3

Compliance	Description	Data	Compliance	Description	Data
N/A	Ramp Length (in)	61.5	No	Ramp Slope (%)	8.9
No	Ramp Width (in)	43.0	No	Ramp XSlope (%)	4.3
N/A	Flare Type LT	N/A	N/A	Flare Type RT	N/A
N/A	Flare Slope LT (%)	N/A	N/A	Flare Slope RT (%)	N/A
N/A	Flare Traversable LT?	N/A	N/A	Flare Traversable RT?	N/A
N/A	Landing Length (in)	N/A	N/A	DWS Provided?	N/A
N/A	Landing Width (in)	N/A	N/A	DWS Contrast?	N/A
N/A	Landing Slope (%)	N/A	N/A	DWS Length (in)	N/A
N/A	Landing X Slope (%)	N/A	N/A	DWS Full Width?	N/A
N/A	Landing Curb? (Y/N)	N/A	N/A	DWS Offset (in)	N/A
N/A	Shared Landing?	N/A			
N/A	Gutter Ponding?	N/A	N/A	Gutter Slope (%)	N/A
N/A	Gutter Lip Ht (in)	N/A	N/A	Gutter X Slope (%)	N/A
N/A	Painted X Walk1?	No	N/A	Painted X Walk2?	No
	X Walk 1 Direction	To N		X Walk 2 Direction	To W
N/A	X Walk 1 Width (in)	N/A	N/A	X Walk 2 Width (in)	N/A
	X Walk 1 Slope (%)	2.1		X Walk 2 Slope (%)	0.4
	X Walk 1 X Slope (%)	6.0		X Walk 2 X Slope (%)	1.8

N/A	Ramp inside XWalk1?	N/A	N/A	Ramp inside XWalk2?	N/A
	Road Slope (%)	5.8	N/A	Clear Space?	N/A
	Road X Slope (%)	4.4	N/A	Clear Space to XWalk (in)	N/A
N/A	Any Obstructions?	N/A	N/A	Storm Grate/Utility Hazard?	N/A
	Obstruction Type			Storm Grate/Utility Type	
		N/A			N/A
			Yes	Surface Condition? (G/P)	Good

Remove & Replace Curb Ramp With Two New Directional Ramps or Equivalent.
