Access Compliance Report

Public Rights-of-Way

(Curb Ramps)

Intersection ID: 10032566	Main Street: N_GRAHAM_ST	Cross Street: N/A	Location: S
ADA ID: A13EDF2E3D78	Ramp Type: Para	Initial Pass/Fail: Pass	Overall Compliance: Yes
		Severity Score: 0

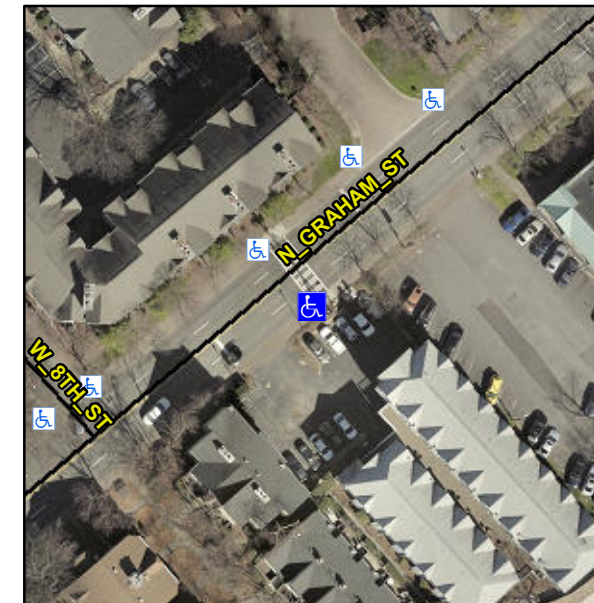
Compliance	Description	Data	Compliance	Description	Data
N/A	Ramp Length LT (in)	48.8	N/A	Ramp Length RT (in)	48.0
Yes	Ramp Width LT (in)	67.0	Yes	Ramp Width RT (in)	66.0
Yes	Ramp Slope LT (%)	5.2	Yes	Ramp Slope RT (%)	3.5
Yes	Ramp XSlope LT (%)	0.8	Yes	Ramp XSlope RT (%)	0.6
Yes	Landing Length (in)	67.0	Yes	DWS Provided?	Yes
Yes	Landing Width (in)	71.0	Yes	DWS Contrast?	Yes
Yes	Landing Slope (%)	0.8	Yes	DWS Length (in)	24.0
Yes	Landing X Slope (%)	0.5	Yes	DWS Full Width?	Yes
N/A	Landing Curb? (Y/N)	Yes	Yes	DWS Offset (in)	0.0
N/A	Shared Landing?	No			
Yes	Gutter Ponding?	No	Yes	Gutter Slope (%)	1.7
Yes	Gutter Lip Ht (in)	0.0	Yes	Gutter X Slope (%)	1.1
N/A	Painted X Walk1?	Yes	N/A	Painted X Walk2?	N/A
	X Walk 1 Direction	To NW		X Walk 2 Direction	N/A
N/A	X Walk 1 Width (in)	112.0	N/A	X Walk 2 Width (in)	N/A
	X Walk 1 Slope (%)	2.6		X Walk 2 Slope (%)	N/A
	X Walk 1 X Slope (%)	0.4		X Walk 2 X Slope (%)	N/A
Yes	Ramp inside XWalk1?	Yes	N/A	Ramp inside XWalk2?	N/A

Road Slope (%)	N/A	N/A	Clear Space?	Yes
	Road X Slope (%)	N/A	N/A	Clear Space to XWalk (in)	N/A
Yes	Any Obstructions?	No	Yes	Storm Grate/Utility Hazard?	No
	Obstruction Type			Storm Grate/Utility Type	
		N/A			N/A
			Yes	Surface Condition? (G/P)	Good
			Compliant	Curb Slope (%)	5.2
