Access Compliance Report Public Rights-of-Way (Curb Ramps)

Intersection ID: 48608Main Street:BULFINCH RDCross Street:PIEDMONT_ROW_DRLocation:NEADA ID: A148E4AA7576Ramp Type:PerpInitial Pass/Fail:FailOverall Compliance:NoSeverity Score:12.5

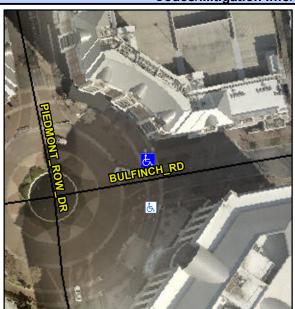
Field Measurements/Component Compliance						
Compliance Description			Data	Comp	oliance Description	Data
	N/A	Ramp Length (in)	102.0	No	Ramp Slope (%)	8.5
,	Yes	Ramp Width (in)	113.0	Yes	Ramp XSlope (%)	1.6
ı	N/A	Flare Type LT	N/A	N/A	Flare Type RT	N/A
ı	N/A	Flare Slope LT (%)	N/A	N/A	Flare Slope RT (%)	N/A
ı	N/A	Flare Traversable LT?	N/A	N/A	Flare Traversable RT?	N/A
ı	N/A	Landing Length (in)	N/A	N/A	DWS Provided?	N/A
ı	N/A	Landing Width (in)	N/A	N/A	DWS Contrast?	N/A
ı	N/A	Landing Slope (%)	N/A	N/A	DWS Length (in)	N/A
ı	N/A	Landing X Slope (%)	N/A	N/A	DWS Full Width?	N/A
ı	N/A	Landing Curb? (Y/N)	N/A	N/A	DWS Offset (in)	N/A
ı	N/A	Shared Landing?	N/A			
ı	N/A	Gutter Ponding?	N/A	N/A	Gutter Slope (%)	N/A
ı	N/A	Gutter Lip Ht (in)	N/A	N/A	Gutter X Slope (%)	N/A
ı	N/A	Painted X Walk1?	Yes	N/A	Painted X Walk2?	N/A
		X Walk 1 Direction	To S		X Walk 2 Direction	N/A
ı	N/A	X Walk 1 Width (in)	123.0	N/A	X Walk 2 Width (in)	N/A

X Walk 1 Slope (%)	0.4		X Walk 2 Slope (%)	N/A
		X Walk 1 X Slope (%)	3.3		X Walk 2 X Slope (%)	N/A
ı	N/A	Ramp inside XWalk1?	Yes	N/A	Ramp inside XWalk2?	N/A
		Road Slope (%)	N/A	N/A	Clear Space?	N/A
		Road X Slope (%)	N/A	N/A	Clear Space to XWalk (in)	N/A
	N/A	Any Obstructions?	N/A	N/A	Storm Grate/Utility Hazard?	N/A
		Obstruction Type			Storm Grate/Utility Type	
			N/A			N/A
				Yes	Surface Condition? (G/P)	Good
			,	-

Possible Solutions:

Remove & Replace Entire Ramp.

PROW/ADA:

R304.2.2
