# Access Compliance Report

## Public Rights-of-Way

### (Curb Ramps)

Intersection ID: N/A	Main Street: EASTWAY_DR	Cross Street: N/A	Location: NW
ADA ID: A152B1D3EEF4	Ramp Type: PerpDiag	Initial Pass/Fail: Fail	Overall Compliance: No
		Severity Score: 10

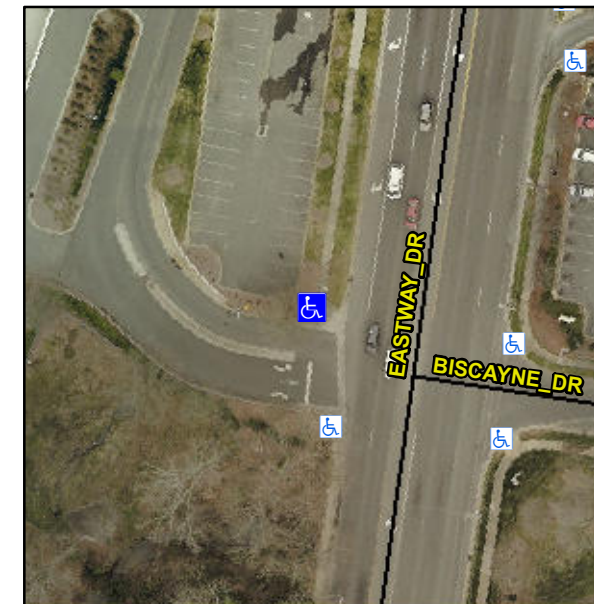
**Not Found, R304.5.1, R304.5.3**

Compliance	Description	Data	Compliance	Description	Data
N/A	Ramp Length (in)	61.0	Yes	Ramp Slope (%)	5.4
No	Ramp Width (in)	45.0	No	Ramp XSlope (%)	4.0
N/A	Flare Type LT	N/A	N/A	Flare Type RT	N/A
N/A	Flare Slope LT (%)	N/A	N/A	Flare Slope RT (%)	N/A
N/A	Flare Traversable LT?	N/A	N/A	Flare Traversable RT?	N/A
N/A	Landing Length (in)	N/A	N/A	DWS Provided?	N/A
N/A	Landing Width (in)	N/A	N/A	DWS Contrast?	N/A
N/A	Landing Slope (%)	N/A	N/A	DWS Length (in)	N/A
N/A	Landing X Slope (%)	N/A	N/A	DWS Full Width?	N/A
N/A	Landing Curb? (Y/N)	N/A	N/A	DWS Offset (in)	N/A
N/A	Shared Landing?	N/A			
N/A	Gutter Ponding?	N/A	N/A	Gutter Slope (%)	N/A
N/A	Gutter Lip Ht (in)	N/A	N/A	Gutter X Slope (%)	N/A
N/A	Painted X Walk1?	No	N/A	Painted X Walk2?	No
	X Walk 1 Direction	To S		X Walk 2 Direction	To E
N/A	X Walk 1 Width (in)	N/A	N/A	X Walk 2 Width (in)	N/A
	X Walk 1 Slope (%)	0.5		X Walk 2 Slope (%)	1.7
	X Walk 1 X Slope (%)	8.2		X Walk 2 X Slope (%)	1.4

N/A	Ramp inside XWalk1?	N/A	N/A	Ramp inside XWalk2?	N/A
	Road Slope (%)	5.6	N/A	Clear Space?	N/A
	Road X Slope (%)	6.3	N/A	Clear Space to XWalk (in)	N/A
N/A	Any Obstructions?	N/A	N/A	Storm Grate/Utility Hazard?	N/A
	Obstruction Type			Storm Grate/Utility Type	
		N/A			N/A
			Yes	Surface Condition? (G/P)	Good

**Remove & Replace Curb Ramp With Two New Directional Ramps or Equivalent.**
