## **Access Compliance Report Public Rights-of-Way** (Curb Ramps)

Intersection ID: 54321 Main Street: BELMONT MANSION DR **Cross Street: WRIGLEY MANSION DR** Location: SW **ADA ID: A15DBBC24AEE** Ramp Type: Directional1 Initial Pass/Fail: Fail **Overall Compliance: No Severity Score:** 12.5

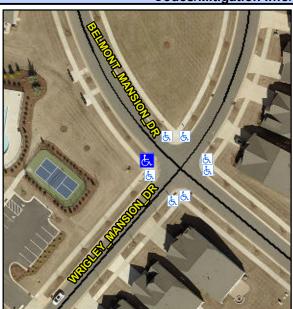
Field Measurements/Component Compliance					
Compliance Description		Data	Compl	iance Description	Data
N/A	Ramp Length (in)	98.0	N/A	Grade Break?	N/A
Yes	Ramp Width (in)	48.0	N/A	Grade Break Slope (%)	0.0
Yes	Ramp Slope (%)	6.4	N/A	Grade Break XSlope (%)	0.0
No	Ramp XSlope (%)	5.3			
N/A	Flare Type LT	N/A	N/A	Flare Type RT	N/A
N/A	Flare Slope LT (%)	N/A	N/A	Flare Slope RT (%)	0.0
N/A	Flare Traversable LT?	N/A	N/A	Flare Traversable RT?	N/A
N/A	Landing Length (in)	0.0	N/A	DWS Provided?	N/A
N/A	Landing Width (in)	0.0	N/A	DWS Contrast?	N/A
N/A	Landing Slope (%)	0.0	N/A	DWS Length (in)	N/A
N/A	Landing X Slope (%)	0.0	N/A	DWS Full Width?	N/A
N/A	Landing Curb? (Y/N)	N/A	N/A	DWS Offset LT (in)	N/A
N/A	Shared Landing?	N/A	N/A	DWS Offset RT (in)	N/A
N/A	Gutter Ponding?	0.0	N/A	Gutter Slope (%)	N/A
N/A	Gutter Lip Ht (in)	1.0	N/A	Gutter X Slope (%)	N/A
N/A	Painted X Walk1?	No		Road Slope (%)	2.8
	X Walk 1 Direction	To NE		Road X Slope (%)	0.5

X Walk 1 Width (in)	N/A		Clear Space?	N/A
	X Walk 1 Slope (%)	2.8	N/A	Clear Space to XWalk (in)	N/A
	X Walk 1 X Slope (%)	0.5	N/A	Storm Grate/Utility Hazard?	N/A
N/A	Ramp inside XWalk1?	N/A		Storm Grate/Utility Type	
N/A	Any Obstructions?	N/A			N/A
	Obstruction Type		Yes	Surface Condition? (G/P)	Good
		N/A	N/A	Curb Slope (%)	7.5

Street 1 Name **BELMONT MANSION DR** Stop Condition-Street 1 None Street 2 Name N/A Stop Condition-Street 2 N/A Possible Solutions: Remove & Replace Entire Ramp. Surveyor Notes: N/A PROW/ADA: R304.5.3
