# Access Compliance Report

## Public Rights-of-Way

| Intersection ID: 12012 | Main Street: PARSON_ST | Cross Street: KENNON_ST | Location: E |
| ADA ID: A15E78D40C57 | Ramp Type: Perp | Initial Pass/Fail: Fail | Overall Compliance: No |

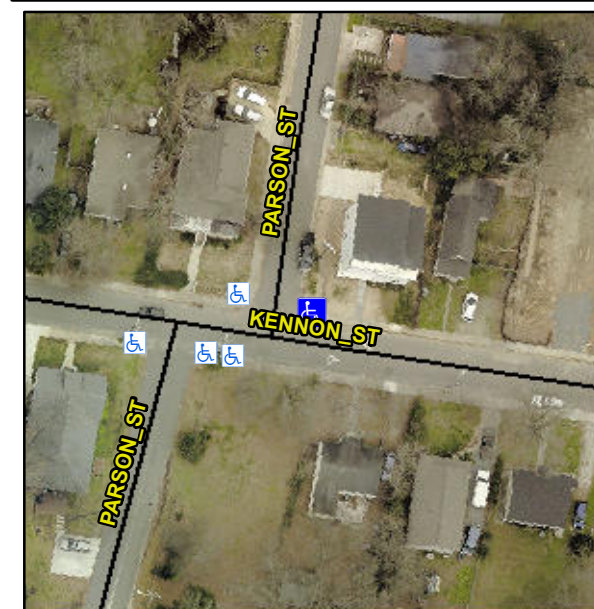
**Not Found, R304.5.1, R304.5.3**

| Compliance | Description | Data | Compliance | Description | Data |
|---|---|---|---|---|---|
| N/A | Ramp Length (in) | 36.0 | Yes | Ramp Slope (%) | 6.5 |
| No | Ramp Width (in) | 42.0 | No | Ramp XSlope (%) | 5.5 |
| N/A | Gutter Lip Ht (in) | 1.5 | N/A | Gutter X Slope (%) | N/A |

**Remove & Replace Entire Ramp.**

Total Cost: \$ 1850.00
