Access Compliance Report

Public Rights-of-Way

(Curb Ramps)

Intersection ID: 10024974	Main Street: DIXIE_RIVER_RD	Cross Street: N/A	Location: S
ADA ID: A15FEA378071	Ramp Type: Perp	Initial Pass/Fail: Fail	Overall Compliance: No
Codes/Mitigation Info/Possible Solution		Field Measurements/Component Compliance	
Severity Score: 12.5

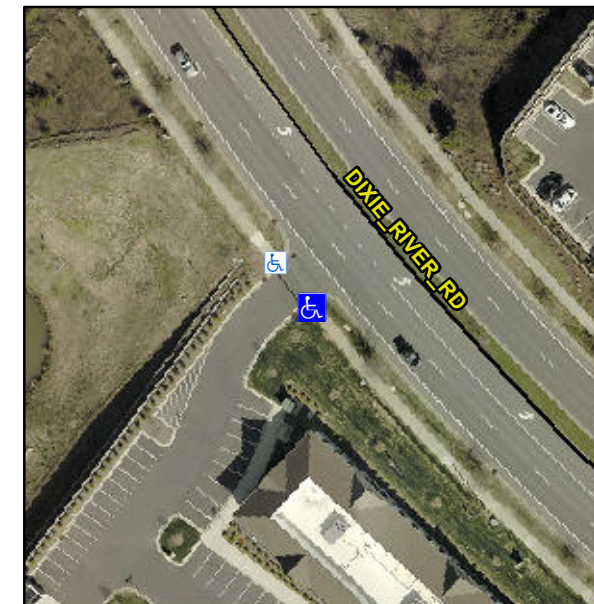
Not Found, R304.2.2

Compliance	Description	Data	Compliance	Description	Data
N/A	Ramp Length (in)	73.0	No	Ramp Slope (%)	9.0
Yes	Ramp Width (in)	48.0	Yes	Ramp XSlope (%)	1.1
N/A	Flare Type LT	N/A	N/A	Flare Type RT	N/A
N/A	Flare Slope LT (%)	N/A	N/A	Flare Slope RT (%)	N/A
N/A	Flare Traversable LT?	N/A	N/A	Flare Traversable RT?	N/A
N/A	Landing Length (in)	N/A	N/A	DWS Provided?	N/A
N/A	Landing Width (in)	N/A	N/A	DWS Contrast?	N/A
N/A	Landing Slope (%)	N/A	N/A	DWS Length (in)	N/A
N/A	Landing X Slope (%)	N/A	N/A	DWS Full Width?	N/A
N/A	Landing Curb? (Y/N)	N/A	N/A	DWS Offset (in)	N/A
N/A	Shared Landing?	N/A			
N/A	Gutter Ponding?	N/A	N/A	Gutter Slope (%)	N/A
N/A	Gutter Lip Ht (in)	N/A	N/A	Gutter X Slope (%)	N/A
N/A	Painted X Walk1?	No	N/A	Painted X Walk2?	N/A
	X Walk 1 Direction	To N		X Walk 2 Direction	N/A
N/A	X Walk 1 Width (in)	N/A	N/A	X Walk 2 Width (in)	N/A
	X Walk 1 Slope (%)	5.0		X Walk 2 Slope (%)	N/A
	X Walk 1 X Slope (%)	1.1		X Walk 2 X Slope (%)	N/A

Possible Solutions:

Remove & Replace Entire Ramp.

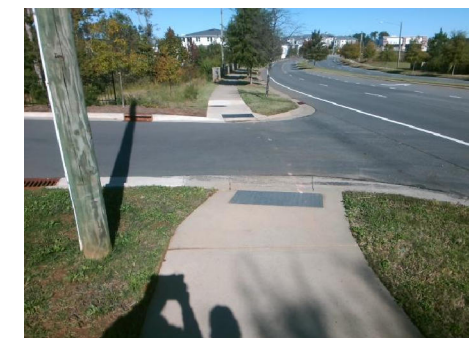
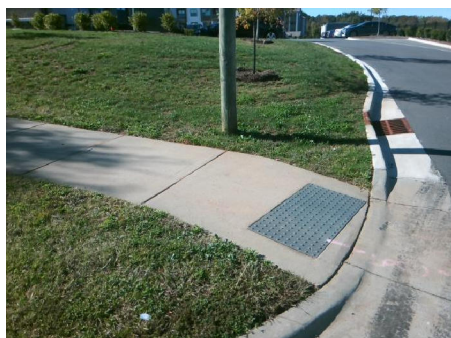
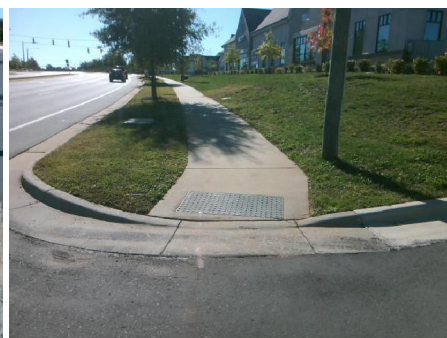
N/A	Ramp inside XWalk1?	N/A	N/A	Ramp inside XWalk2?	N/A
	Road Slope (%)	N/A	N/A	Clear Space?	N/A
	Road X Slope (%)	N/A	N/A	Clear Space to XWalk (in)	N/A
N/A	Any Obstructions?	N/A	N/A	Storm Grate/Utility Hazard?	N/A
	Obstruction Type			Storm Grate/Utility Type	
		N/A			N/A
			Yes	Surface Condition? (G/P)	Good
