# Access Compliance Report

## Public Rights-of-Way

### (Curb Ramps)

Intersection ID: 16083	Main Street: LLEWELLYN_PL	Cross Street: LOCKLEY_DR	Location: NE
ADA ID: A17382200BF6	Ramp Type: PerpDiag	Initial Pass/Fail: Fail	Overall Compliance: No
		Severity Score: 12.5

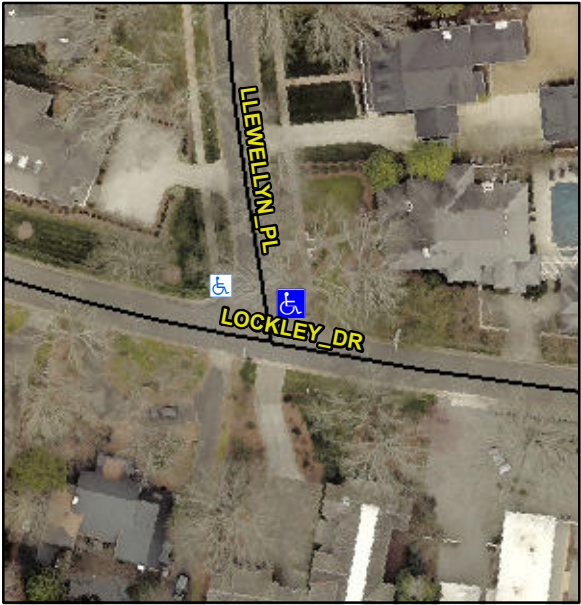
<p>Street 1 Name: LLEWELLYN PL</p> <p>Stop Condition-Street 2: StopSign</p> <p>Street 2 Name: LOCKLEY DR</p> <p>Stop Condition-Street 1: None</p>	Possible Solutions:	Compliance	Description	Data	Compliance	Description	Data
	Remove & Replace Curb Ramp With Two New Directional Ramps or Equivalent.	N/A	Ramp Length (in)	105.0	No	Ramp Slope (%)	9.5
		Yes	Ramp Width (in)	55.0	Yes	Ramp XSlope (%)	2.0
		N/A	Flare Type LT	N/A	N/A	Flare Type RT	N/A
		N/A	Flare Slope LT (%)	N/A	N/A	Flare Slope RT (%)	N/A
		N/A	Flare Traversable LT?	N/A	N/A	Flare Traversable RT?	N/A
		N/A	Landing Length (in)	N/A	N/A	DWS Provided?	N/A
		N/A	Landing Width (in)	N/A	N/A	DWS Contrast?	N/A
		N/A	Landing Slope (%)	N/A	N/A	DWS Length (in)	N/A
		N/A	Landing X Slope (%)	N/A	N/A	DWS Full Width?	N/A
		N/A	Landing Curb? (Y/N)	N/A	N/A	DWS Offset (in)	N/A

N/A	Shared Landing?	N/A			
		N/A	Gutter Ponding?	N/A	N/A	Gutter Slope (%)	N/A
		N/A	Gutter Lip Ht (in)	N/A	N/A	Gutter X Slope (%)	N/A
		N/A	Painted X Walk1?	No	N/A	Painted X Walk2?	No
			X Walk 1 Direction	To NW		X Walk 2 Direction	To S
		N/A	X Walk 1 Width (in)	N/A	N/A	X Walk 2 Width (in)	N/A
			X Walk 1 Slope (%)	2.3		X Walk 2 Slope (%)	0.6
			X Walk 1 X Slope (%)	1.0		X Walk 2 X Slope (%)	0.1
		N/A	Ramp inside XWalk1?	N/A	N/A	Ramp inside XWalk2?	N/A
<p>Surveyor Notes:</p> <p>N/A</p> <p>PROW/ADA:</p> <p>R304.2.2</p>			Road Slope (%)	2.7	N/A	Clear Space?	N/A
			Road X Slope (%)	5.4	N/A	Clear Space to XWalk (in)	N/A
		N/A	Any Obstructions?	N/A	N/A	Storm Grate/Utility Hazard?	N/A
			Obstruction Type			Storm Grate/Utility Type	
				N/A			N/A
					Yes	Surface Condition? (G/P)	Good
Total Cost:		\$	3200.00
