# Access Compliance Report

## Public Rights-of-Way

### (Curb Ramps)

| Intersection ID: 45498 | Main Street: COTTON_PRESS_RD | Cross Street: GRASSY_CROPS_RD | Location: W |

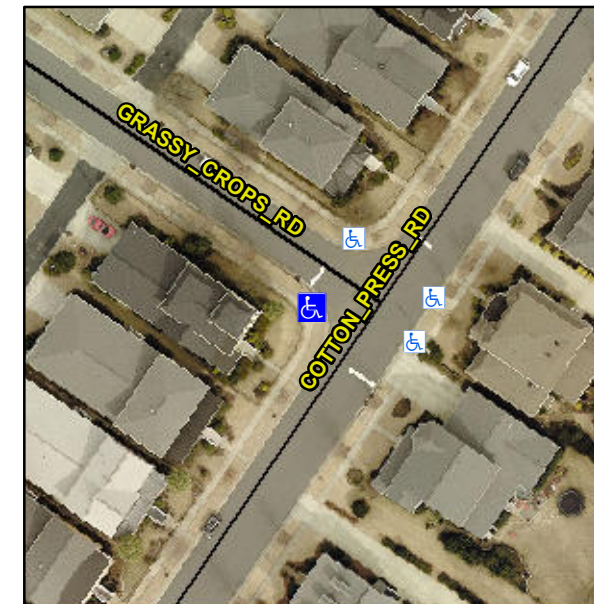
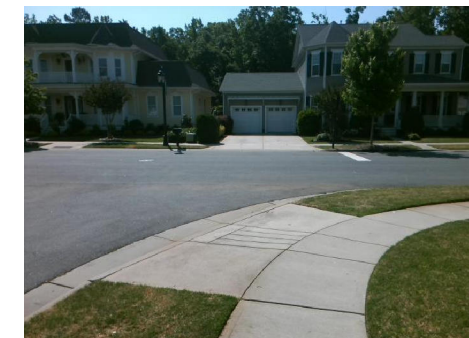
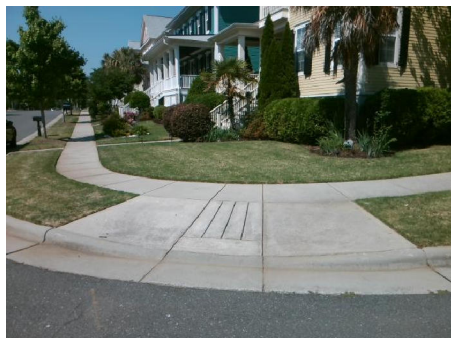
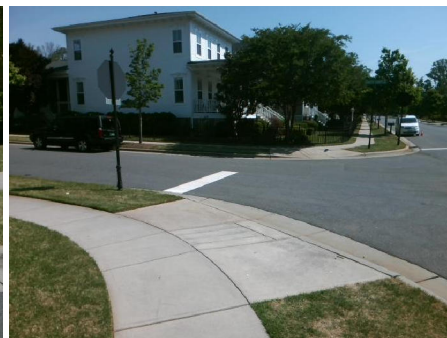
| ADA ID: A173ADD8D7A6 | Ramp Type: PerpDiag | Initial Pass/Fail: Fail | Overall Compliance: No |
| | | Severity Score: 35 | |

**Not Found, R304.5.1, R304.2.2, R304.5.3**

| Compliance | Description | Data | Compliance | Description | Data |
|---|---|---|---|---|---|
| N/A | Ramp Length (in) | 70.0 | No | Ramp Slope (%) | 13.2 |
| No | Ramp Width (in) | 36.0 | No | Ramp XSlope (%) | 2.5 |

**Remove & Replace Curb Ramp With Two New Directional Ramps or Equivalent.**

Total Cost: \$ 3200.00
