Access Compliance Report

Public Rights-of-Way

(Curb Ramps)

Intersection ID: 9648	Main Street: TIMBERBROOK_DR	Cross Street: TUCKASEEGEE_RD	Location: SE
ADA ID: A18238BB6C89	Ramp Type: Directional1	Initial Pass/Fail: Fail	Overall Compliance: No
			Severity Score: 13.75

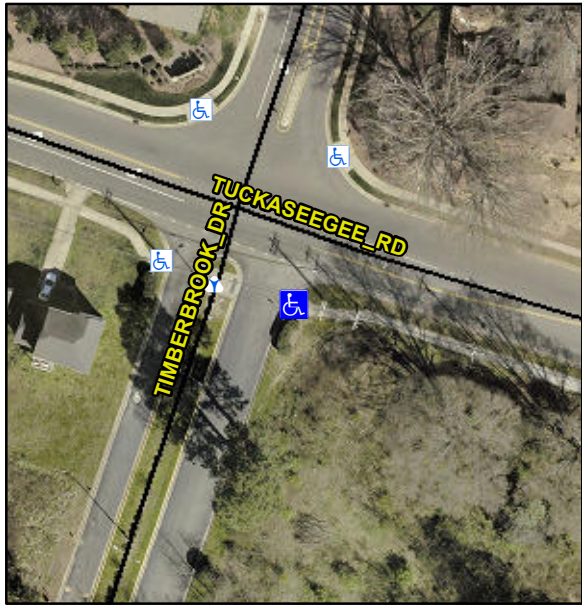
Possible Solutions:		Compliance	Description	Data	Compliance	Description	Data
	Remove & Replace Entire Ramp.		N/A	Ramp Length (in)	59.0	N/A	Grade Break?	N/A
			Yes	Ramp Width (in)	70.5	N/A	Grade Break Slope (%)	0.0
			No	Ramp Slope (%)	9.4	N/A	Grade Break XSlope (%)	0.0
			No	Ramp XSlope (%)	2.2			
			N/A	Flare Type LT	N/A	N/A	Flare Type RT	N/A
			N/A	Flare Slope LT (%)	N/A	N/A	Flare Slope RT (%)	0.0
			N/A	Flare Traversable LT?	N/A	N/A	Flare Traversable RT?	N/A
			N/A	Landing Length (in)	0.0	N/A	DWS Provided?	N/A
			N/A	Landing Width (in)	0.0	N/A	DWS Contrast?	N/A
Surveyor Notes:		N/A	N/A	Landing Slope (%)	0.0	N/A	DWS Length (in)	N/A
		N/A	N/A	Landing X Slope (%)	0.0	N/A	DWS Full Width?	N/A
PROW/ADA:		N/A	N/A	Landing Curb? (Y/N)	N/A	N/A	DWS Offset LT (in)	N/A
R304.2.2, R304.5.3		N/A	N/A	Shared Landing?	N/A	N/A	DWS Offset RT (in)	N/A

N/A	N/A	Gutter Ponding?	0.0	N/A	Gutter Slope (%)	N/A
		N/A	N/A	Gutter Lip Ht (in)	0.0	N/A	Gutter X Slope (%)	N/A
		N/A	N/A	Painted X Walk1?	No		Road Slope (%)	0.1
				X Walk 1 Direction	To W		Road X Slope (%)	5.9
				X Walk 1 Width (in)	N/A		Clear Space?	N/A
				X Walk 1 Slope (%)	0.1	N/A	Clear Space to XWalk (in)	N/A
				X Walk 1 X Slope (%)	5.9	N/A	Storm Grate/Utility Hazard?	N/A
		N/A	N/A	Ramp inside XWalk1?	N/A		Storm Grate/Utility Type	
		N/A	N/A	Any Obstructions?	N/A			N/A
				Obstruction Type		Yes	Surface Condition? (G/P)	Good
					N/A	N/A	Curb Slope (%)	9.7
Total Cost:		\$ 1600.00
