Access Compliance Report

Public Rights-of-Way

(Curb Ramps)

Intersection ID: 14006	Main Street: ELIZABETH_AV	Cross Street: HAWTHORNE_LN	Location: E
ADA ID: A19045F41C2E	Ramp Type: Directional2	Initial Pass/Fail: Fail	Overall Compliance: No
Severity Score: 13.75			
Codes/Mitigation Info/Possible Solution		Field Measurements/Component Compliance

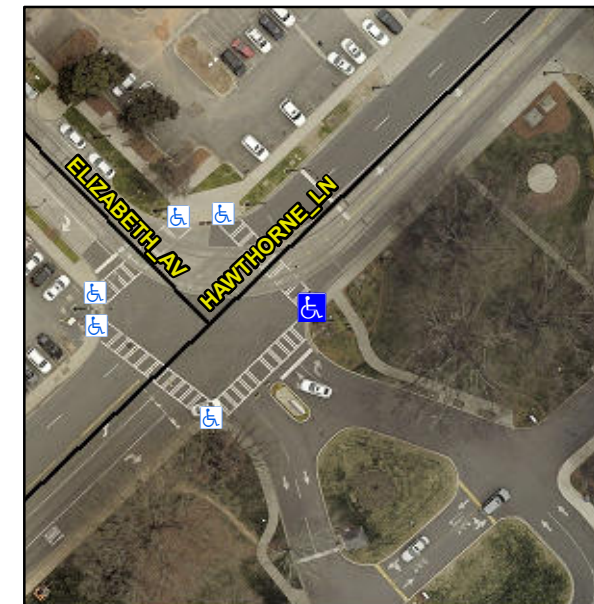
R304.2.2, R304.5.3

Compliance	Description	Data	Compliance	Description	Data
N/A	Ramp Length (in)	72.0	N/A	Grade Break?	N/A
Yes	Ramp Width (in)	49.0	N/A	Grade Break Slope (%)	0.0
No	Ramp Slope (%)	8.8	N/A	Grade Break XSlope (%)	0.0
No	Ramp XSlope (%)	5.0			
N/A	Flare Type LT	N/A	N/A	Flare Type RT	N/A
N/A	Flare Slope LT (%)	N/A	N/A	Flare Slope RT (%)	0.0
N/A	Flare Traversable LT?	N/A	N/A	Flare Traversable RT?	N/A
N/A	Landing Length (in)	0.0	N/A	DWS Provided?	N/A
N/A	Landing Width (in)	0.0	N/A	DWS Contrast?	N/A
N/A	Landing Slope (%)	0.0	N/A	DWS Length (in)	N/A
N/A	Landing X Slope (%)	0.0	N/A	DWS Full Width?	N/A
N/A	Landing Curb? (Y/N)	N/A	N/A	DWS Offset LT (in)	N/A
N/A	Shared Landing?	N/A	N/A	DWS Offset RT (in)	N/A
N/A	Gutter Ponding?	0.0	N/A	Gutter Slope (%)	N/A
N/A	Gutter Lip Ht (in)	0.0	N/A	Gutter X Slope (%)	N/A
N/A	Painted X Walk1?	Yes		Road Slope (%)	0.0
	X Walk 1 Direction	To SW		Road X Slope (%)	3.4
	X Walk 1 Width (in)	112.0		Clear Space?	N/A

X Walk 1 Slope (%)	0.0	N/A	Clear Space to XWalk (in)	N/A
	X Walk 1 X Slope (%)	3.4	N/A	Storm Grate/Utility Hazard?	N/A
N/A	Ramp inside XWalk1?	Yes		Storm Grate/Utility Type	
N/A	Any Obstructions?	N/A			N/A
	Obstruction Type		Yes	Surface Condition? (G/P)	Good
			N/A	Curb Slope (%)	5.2

Possible Solutions:

Remove & Replace Entire Ramp.
